**15 JANUARY 1993  
REV 20 JANUARY 2000**

## **LONG TERM LIFE CYCLE EVALUATION OF TAYLOR DEVICES PRODUCTS**

**BY  
JAMES J. DRAGONETTE  
QUALITY ASSURANCE MANAGER  
TAYLOR DEVICES, INC.**

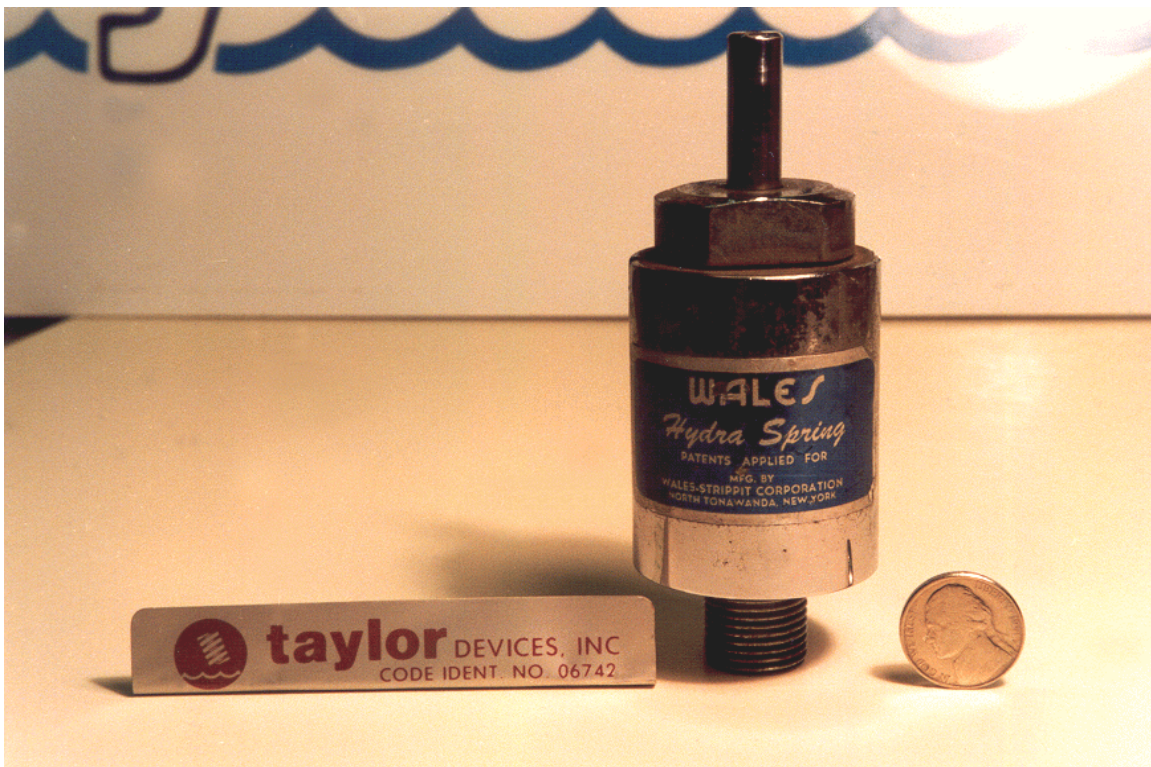
## PHOTO 1

One piece of a Wales-Strippit Hydra Spring-Damper, built prior to 1954 by our predecessor corporation. Chrome plated steel construction, with a chrome plated piston rod.

- a. Taylor Devices' manufactured seal of nylon material.
- b. The Unit is fully functional with no leakage of any type.
- c. Light surface oxidation of the Cylinder, Cap, and Piston Rod, approximately 70% of the Piston Rod area shows this oxidation.
- d. The Unit has been in unprotected indoor storage since at least 1954.

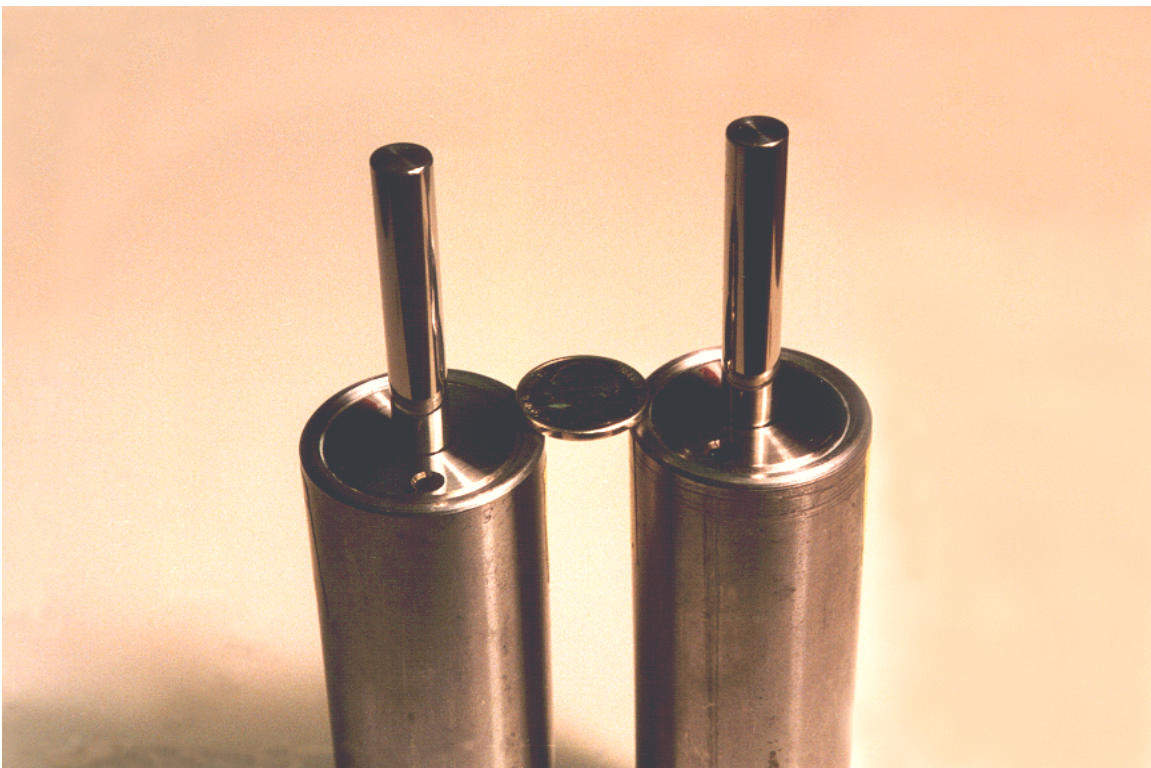
## PHOTO 2

Two pieces of a Model 6232 Fluid Spring-Damper, this model is a standard Taylor product which is still in production today. These Units are control samples which are kept in the company safe for Standard Product Baseline Evaluations. They are marked Units 1 & 2.

- a. Metallic components are a 4140 Cylinder, and 17-4 PH Stainless Steel Cap and Piston Rod. All components are heat treated, the Piston Rod finish is a lapped  $\frac{1}{2}$ -2 Micro-Inch, with a Taylor Devices' manufactured Seal of Teflon material.
- b. The Units were load tested and were found fully functional, with no leakage of any type.
- c. Unit #1 has light rust on the stud end of the 4140 Cylinder. The Cap and Piston Rod are in perfect condition.

Unit #2 has heat treat scale visible on the stud end of the 4140 Cylinder. The Cap and Piston Rod are in perfect condition.

- d. Both Units were assembled on August 13, 1965.
- e. Storage has been in the Company Safe, indoor environment.

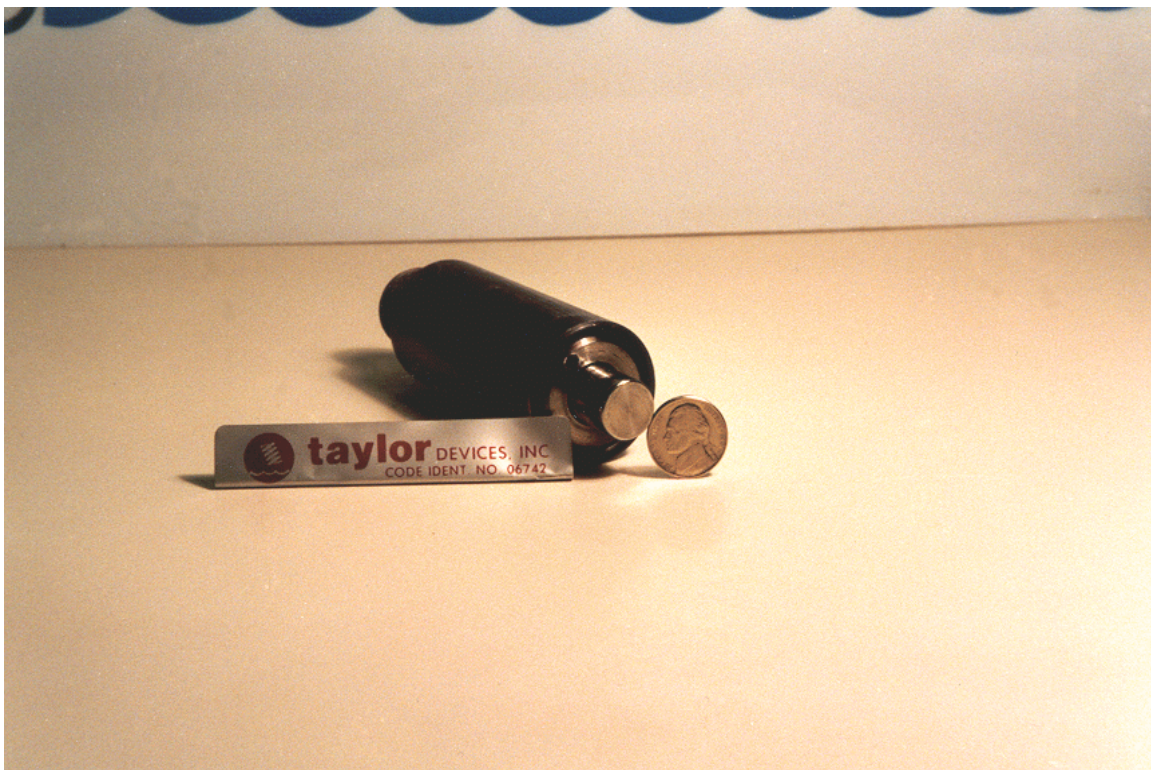
### PHOTO 3

One piece of a Model 6186 Fluid Spring-Damper, this Unit is also a standard Taylor product which is in production today. This Unit is a control sample that is kept in the Company Safe. The Unit is marked Serial Number 9.

- a. Metallic components are a 4140 Cylinder, and 17-4 PH Stainless Steel Cap and Piston Rod. All components are heat treated, the Piston Rod finish is a lapped  $\frac{1}{2}$ -2 Micro-Inch, with a Taylor Devices' manufactured seal of Teflon material.
- b. The Unit was load tested and found fully functional, with no leakage of any type.
- c. This model has a darkened Cylinder. The Cap and Piston Rod are in perfect condition.
- d. This Unit was assembled on November 19, 1965.
- e. Storage has been in the Company safe, an indoor environment.

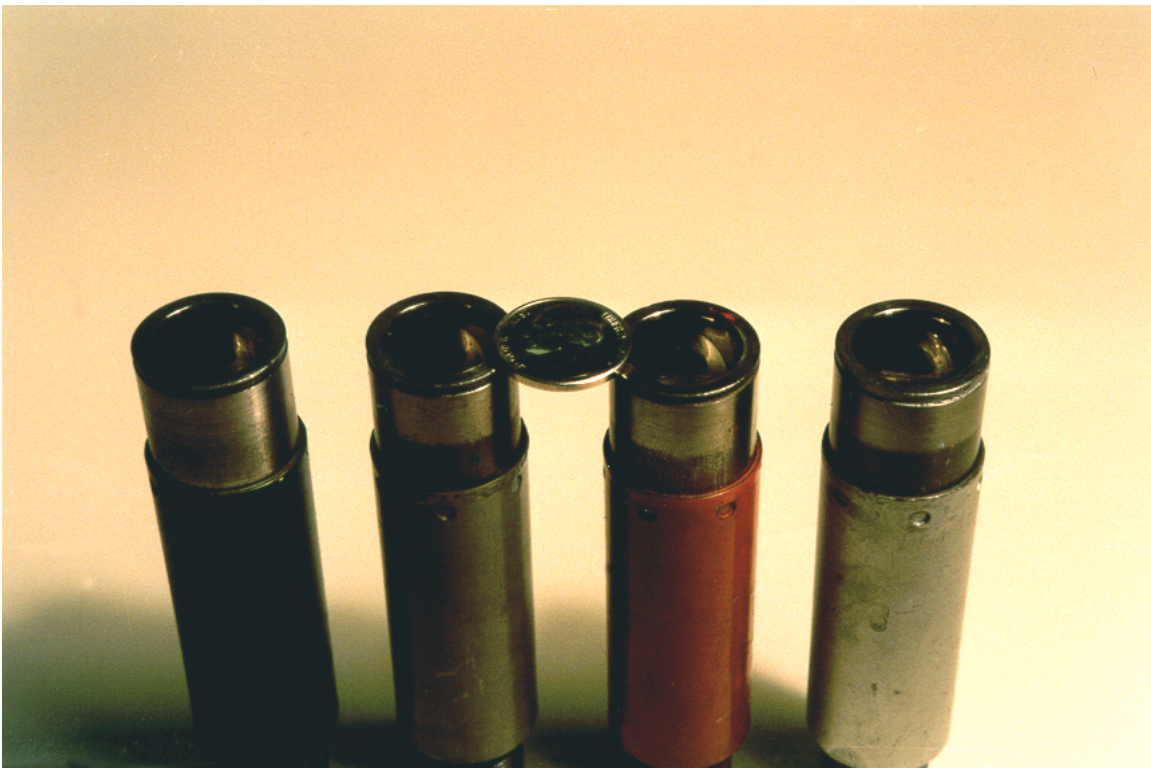
## PHOTO 4

Four pieces of a Model 828.5 Taylor Step-Tubular Shock Absorber. This style Unit is no longer a standard Taylor product. These Units are also control Units and have been in storage.

- a. Metallic components are a 17-4 PH Stainless Steel Cylinder and Piston, with a 4140 Internal Stud. All components are heat treated, the small bore of the Cylinder and the large bore of the Piston are finished to  $\frac{1}{2}$ -2 Micro-Inch.
- b. Taylor Devices' manufactured Seal, 3 Piece, Nylon, and Elastomer materials.
- c. The Units were fully functional, with no leakage of any type.
- d. The exposed Piston bores are in perfect condition.
- e. All Four Units are believed to have been assembled on or about April 15, 1959.
- f. They have been stored in the Company safe, an indoor environment.

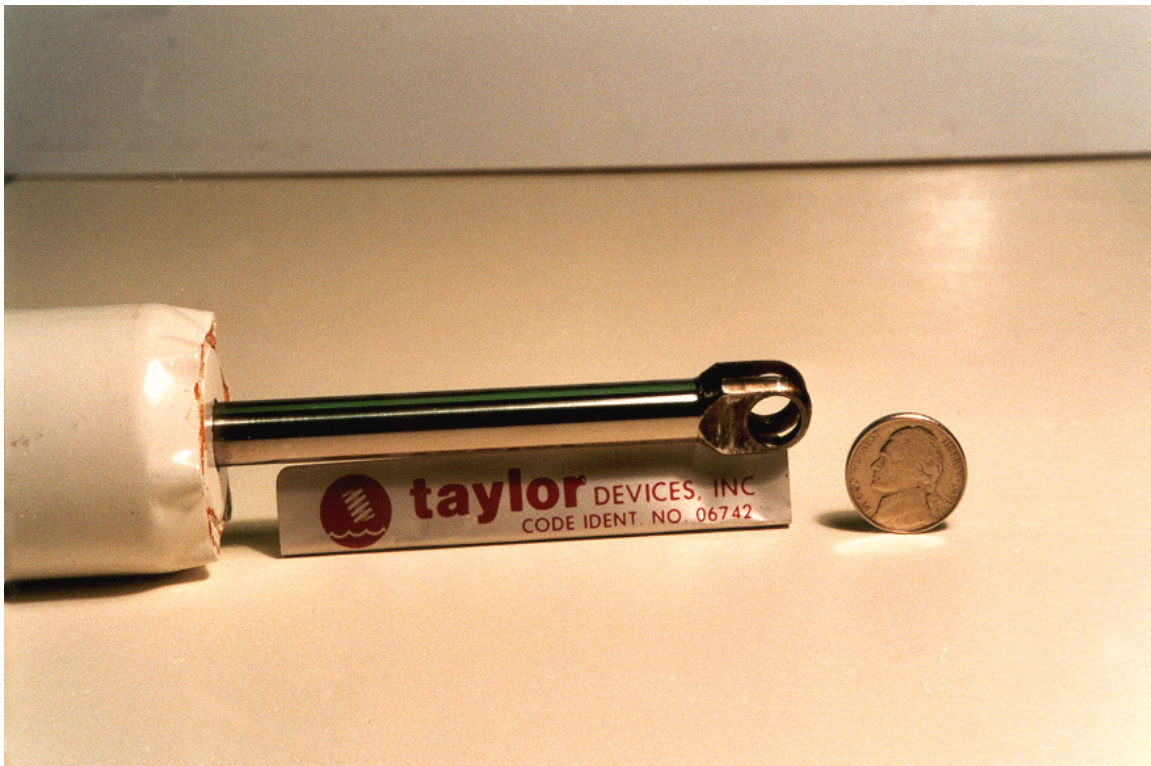
## PHOTO 5

One piece of a Taylor Fluid Spring-Shock Absorber, used in a Float Plane Nose Landing Gear for Tritan Aircraft Corporation. This Unit was excess production and used as a sales sample, Taylor part number 4SS-4248-01.

- a. Metallic components are an 18% Nickel Maraging Steel Cylinder, and 17-4 PH Stainless Steel Cap and Piston Rod. The Cylinder and the Cap End are painted with a white epoxy paint. The Piston Rod has a 6-10 Micro-Inch radial honed finish, with a Taylor Devices' manufactured Seal, Teflon material.
- b. The Unit was load tested and found fully functional, with no leakage of any type.
- c. The painted surfaces are in very good condition, and the Piston Rod finish is in perfect condition.
- d. This Unit was assembled on April 10, 1969.
- e. Storage for this Unit has been in various indoor areas in Taylor Devices' Facility.

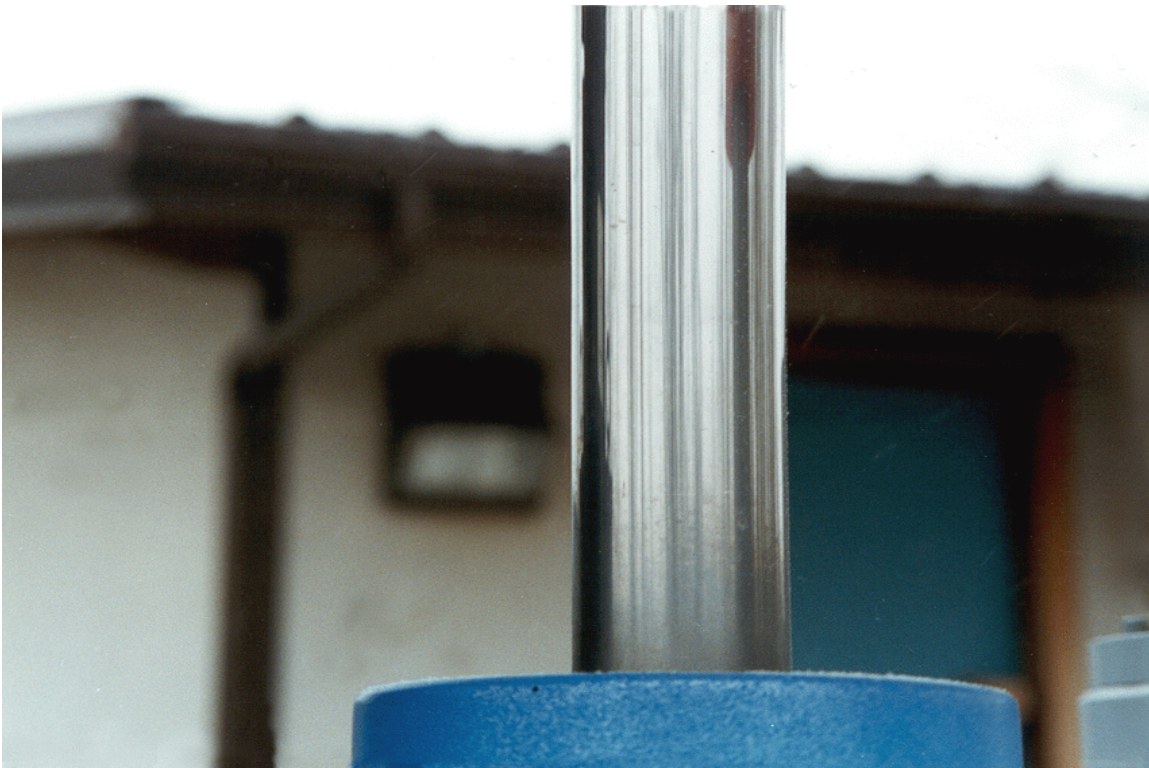
## PHOTO 6

One piece of a 10 x 22 Taylor Crane Buffer. This is a standard Taylor product which is still produced today. This particular Unit was assembled in 1966, and is stored in an unprotected outdoor display area.

- a. Metallic components are a painted carbon steel Cylinder and End Cap, with an exposed 17-4 PH Stainless Steel Piston Rod. The Piston Rod has been heat treated and finished to our standard ½-2 Micro-Inch lapped finish, with Taylor Devices' manufactured Seals of Delrin material.
- b. This Unit could not be load tested, due to its size and location. However, no Fluid leakage was evident.
- c. Paint shows slight peeling around the Cap end. No rust was visible. The Piston Rod has a light coating of atmospheric pollution by-products caused by smog and winter road salt fog in the Buffalo, New York area.
- d. This Unit has been assembled since 1966.
- e. Storage has always been in an outdoors display.
