# **A STUDY IN THE LONG-TERM PERFORMANCE OF SPECIALIZED LOW FRICTION HERMETICALLY SEALED FLUID VISCOUS DAMPERS UNDER NEARLY CONTINUOUS OPERATION ON A PEDESTRIAN BRIDGE**

Alan R. Klembczyk, Vice President, Sales & Engineering  
Douglas P. Taylor, President  
Taylor Devices, Inc.  
North Tonawanda, NY 14120-0748

In 2001, Taylor Devices Inc. developed special Viscous Dampers for use on the Millennium Bridge in London, United Kingdom. These dampers were specified and designed to be used for mitigating the dynamic response of the bridge due to pedestrian traffic. Prior to the integration of the dampers, the bridge had experienced unacceptable movements, especially during periods when larger crowds of people were on the bridge. The result was that the bridge had to be closed until a solution was found. Much research was done and several papers were published about the nature of that problem and the ensuing solution. After successful component level testing and the installation of 37 Taylor Viscous Dampers, the bridge was re-opened to the public in February, 2002. Tests with approximately 2000 people demonstrated a much improved dynamic response. Since that time, the dampers have been s

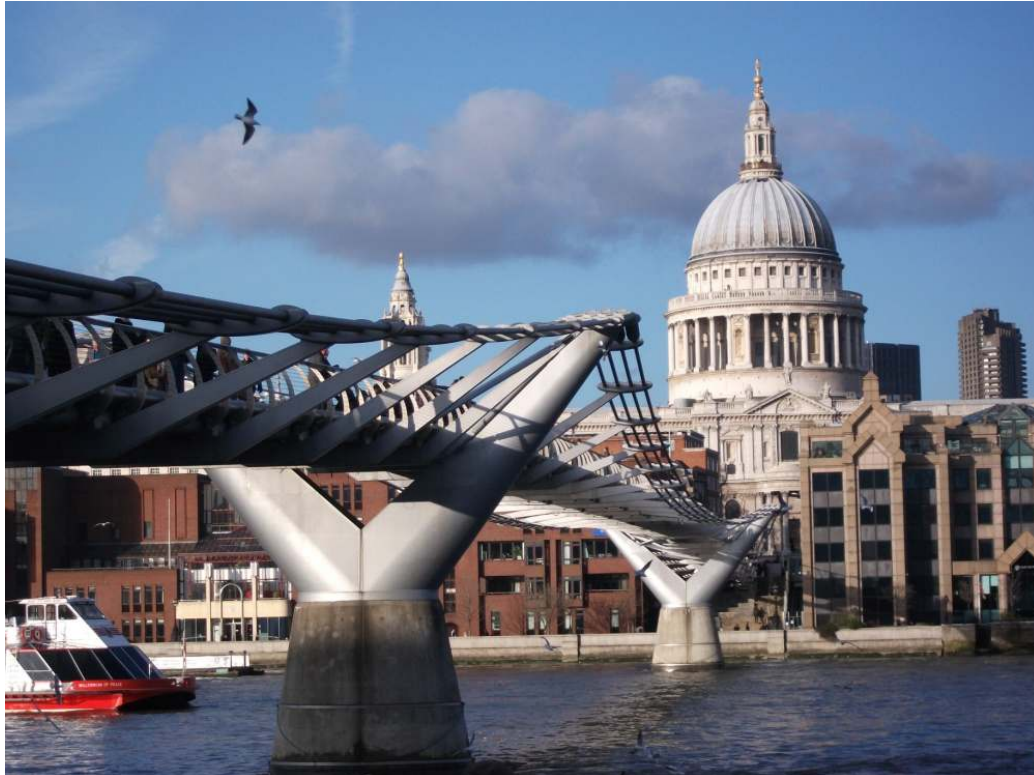
**FIGURE 1 – THE MILLENNIUM BRIDGE**

The unique design and the resulting unacceptable response of the Millennium Bridge in central London (see Figure 1) have been well publicized and documented. The specifics of this dynamic response and the resulting solution will not be reiterated within the context of this paper. However, in order to provide a necessary background, a short summary is presented here.

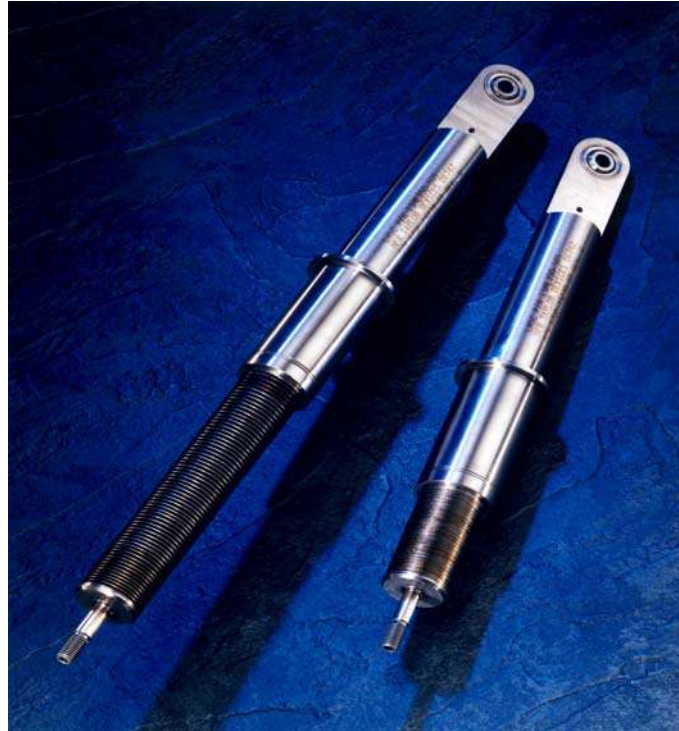
**FIGURE 2 – SPACE SATELLITE DAMPERS**

Taylor Devices' Fluid Dampers with metal bellows seals had been previously used exclusively by NASA and other U.S. Government agencies for space based optical systems. These previous applications had similar requirements for long life and high resolution at low amplitudes, but required relatively low damper forces from small, lightweight design envelopes. Figure 2 is a photograph of a pair of typical dampers of this design, used in space on more than 70 satellites to protect delicate solar array panels. This figure also shows the metal bellows seals; one in the compressed position and one in the extended position. This type of seal does not slide, but rather flexes without hysteresis as the damper moves. This patented design is known as a Frictionless Hermetic Damper.

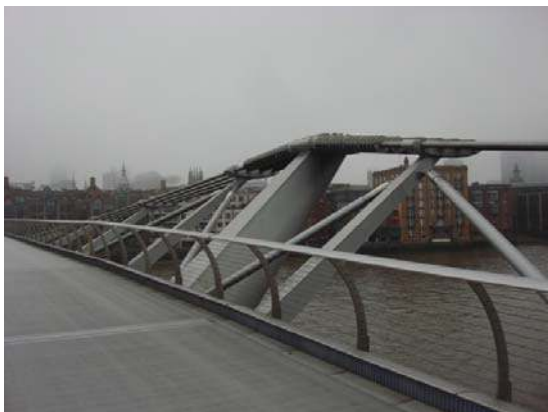
**FIGURE 4  
4 OF 16 PIER DAMPERS**

<b>Damper Nomenclature:</b>	Pier Damper
<b>Quantity on the Bridge:</b>	16
<b>Description:</b>	2 Pier Dampers are located on each side of each of 2 piers on both the east and west side of the bridge, for a total of 8 dampers per pier. Damping coefficient values for the 8 dampers connected directly to the center span of the bridge are significantly higher than the other Pier Dampers. Dampers have varying overall lengths due to the location of the attachment points, the longest being 8.3 meters long. These dampers are quite apparent to pedestrians when crossing the bridge as illustrated in Figures 4 and 5 below:

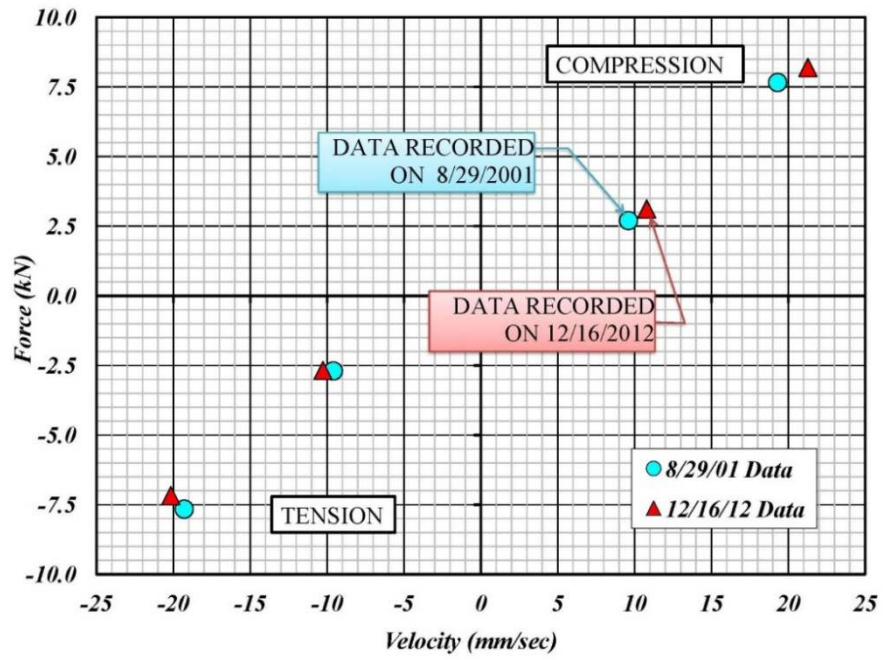
Figures 10, 11, and 12 show the results of the Force versus Velocity tests for each Damper, measuring the output force at several velocity inputs. These plots also show the data points recorded through the same testing methods 11 years prior. The graphical data illustrates the fact that there is virtually no difference in output characteristics when comparing the results from 2001 to the results from 2012. Note that both the 2001 and 2012 tests were run in the same test machine. The calibrated force transducers were strain gage type load cells with  $\pm 2\%$  gage accuracy on output force. The 2012 tests used a calibrated velocity transducer with  $\pm 2\%$  accuracy, whereas the 2001 tests utilized a slope measurement on a calibrated displacement transducer with  $\pm 2\%$  accuracy to obtain velocity.

**FIGURE 10**  
**FORCE VS. VELOCITY TEST RESULTS OF DECK DAMPER**  
**2001 & 2012**

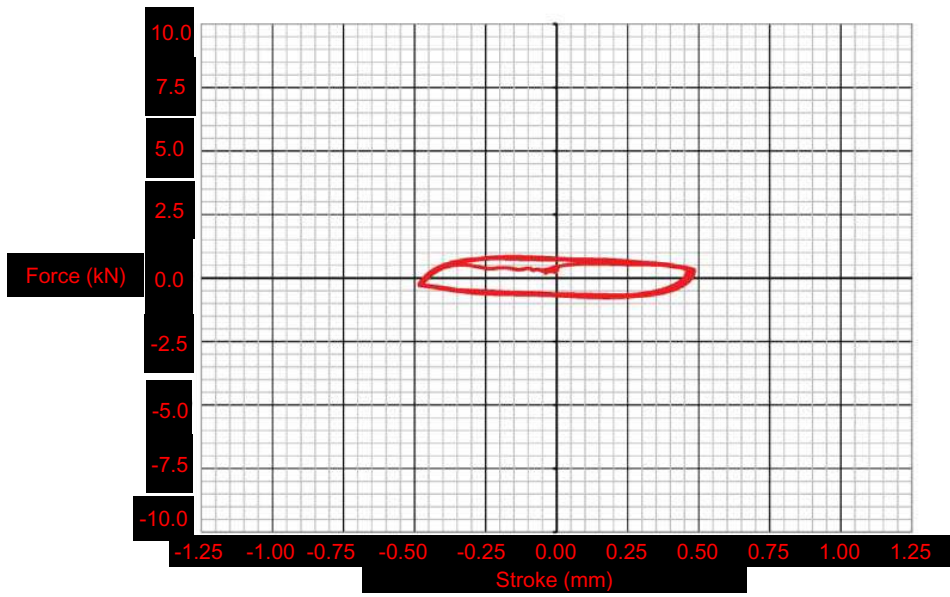
Figures 13, 14 and 15 demonstrate the results of the Low Amplitude Tests for each of the three dampers that were tested. Note that in each case, the hysteresis loops (force vs. displacement) show no signs of free-play, loss of fluid, excessive friction, wear or degradation of any sort. It should be noted that the dampers were tested with their spherical bearings in place and their end attachment brackets still connected. Therefore, no degradation to these components has occurred and the bearings have maintained their tight fit requirement that is necessary to produce damping at very low displacements.

**FIGURE 14**  
**LOW AMPLITUDE TEST RESULTS OF DECK DAMPER**  
**2012**
