# The Winds of Time

Increased wind load requirements and the bad timing of the 2008 economic downturn couldn't keep a Manhattan skyscraper from topping out ahead of schedule.

BY MATT JACKSON, S.E., P.E.

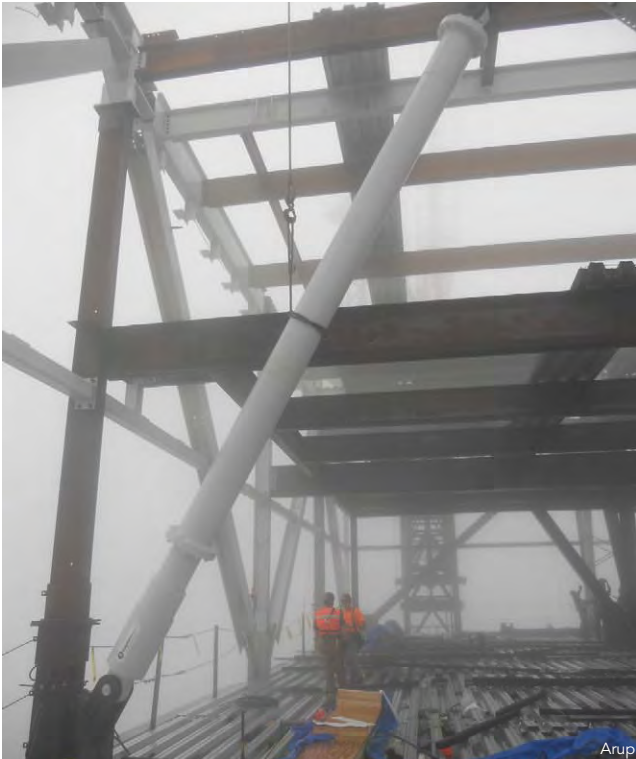
◀ The building uses approximately 10,000 tons of steel in all, 9,000 tons of which were stored for several years while the project was on hold.

In addition to the challenges typical of a large construction project, the 2008 economic crisis also became a factor, hitting just after construction started; the week before the cranes were scheduled to mobilize in March 2009, Boston Properties made the decision to suspend construction until the market was more favorable, and the design and construction team quickly moved to put a plan in place to allow for an orderly demobilization and efficient restart. Foundation construction and steel fabrication was already under way at this time, so the team decided to complete the structure up to grade level to both stabilize the perimeter walls and allow the site to be more easily waterproofed and protected. Fabricator Owen Steel continued fabricating the remaining steel and set up a plan that would allow for storage and monitoring of the steel for an unknown duration and a quick restart when needed. The plan included finding a site large enough to store 9,000 tons of steel, which ended up being spread out over five acres, stacking the steel to avoid the collection of water and minimize corrosion and organizing the steel into the order in which the loads would be needed once construction restarted in the fall of 2011.

At that point, the team was concerned about the corrosion that had developed on the surfaces that had been prepared for slip-critical connections—in particular, those that had been blast cleaned to achieve a Class B surface. The *RCSC Specification* suggests that some corrosion for up to a year should be acceptable, but no further data was available to specify exactly what level of corrosion over what period of time would still perform in a satisfactory way.

We decided to test a sample of representative connections from the stored pieces and verify the coefficient of friction directly. The resulting tests showed that the stored steel exceeded the required 0.5 coefficient of friction. As such the steel required no further blast cleaning and could be trucked straight from the storage yard to the site in the order planned several years earlier.

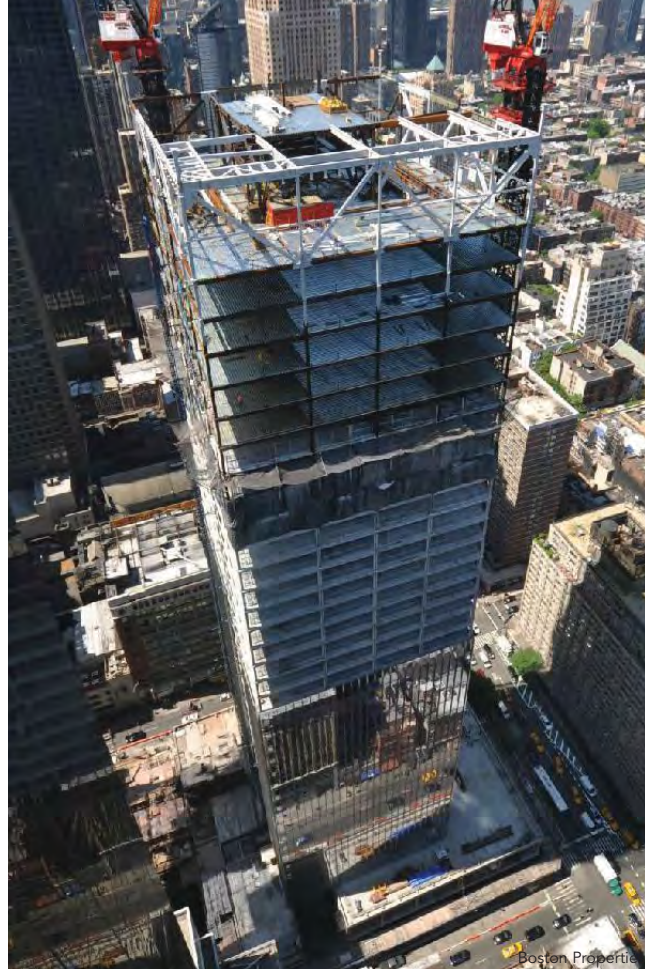
- ▲ Installing the viscous dampers.
- The building's floor structure is based on a 29-ft, 6-in. typical bay size, with spans from core to perimeter varying from 30 ft to 43 ft.
- A layout of the damper system.

Based on these findings, two options for meeting the acceleration limits were considered: Increase the stiffness by approximately 20% or increase the damping. The design team determined that adding damping was the more efficient option and considered several damping methods, including conventional tuned mass dampers (TMD) and sloshing dampers, before finally settling on a system, from Taylor Devices, that effectively replaced some of the braces in the outrigger trusses at the top of the tower with viscous dampers. The specification for the dampers was quite different to those normally used for seismic applications in buildings, as the dampers are required to provide damping at very small displacements but also cycle constantly whenever there are high winds.

Despite the high performance required of the seven dampers, their total cost was significantly less than that of a conventional TMD or sloshing damper. Also, because the final wind tunnel testing revealed that the actual loads were lower than expected—and

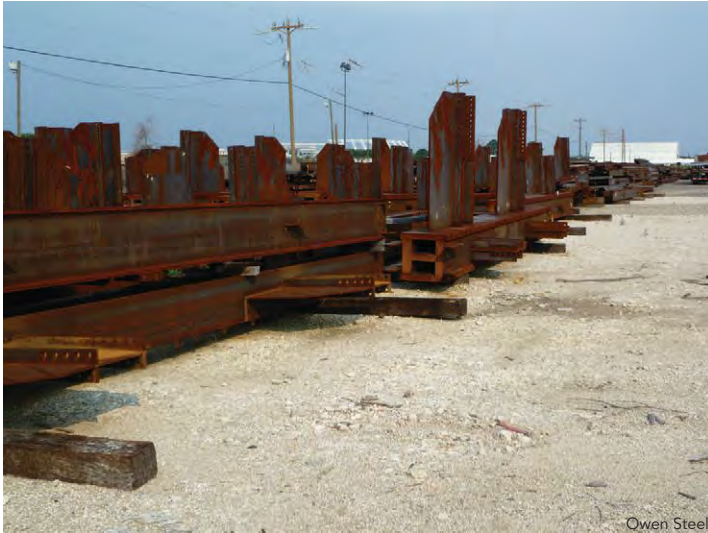
▲ Much of the project's steel resided at fabricator Owen Steel's storage yard while construction was on hold.

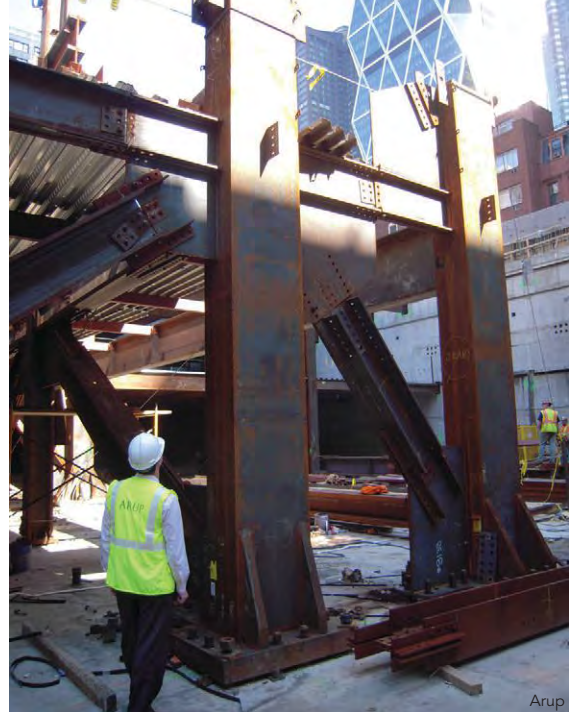
▲ The framing system of the building's basement.

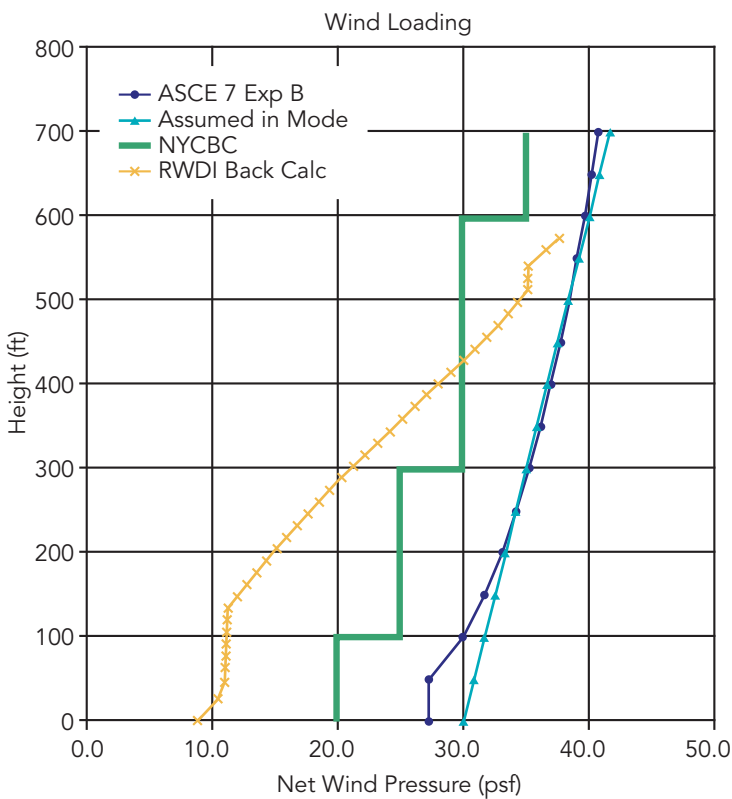
▲ A wind loading comparison for the building.  
▼ The corresponding comparison of the foundation loads.

Model	Wind in X direction				Wind in Y direction			
	Shear		Moment		Shear		Moment	
Load	(k)	%	(k-ft)	%	(k)	%	(k-ft)	%
ASCE 7	2,740	100%	826,567	100%	2,461	100%	742,396	100%
RWDI	1,733	63%	609,134	74%	1,376	56%	504,961	68%
NYC	2,092	76%	647,766	78%	1,879	76%	581,803	78%

design was completed, wind engineering firm RWDI carried out wind tunnel testing, and the initial results showed that the actual wind loads and base moments were lower than those predicted by ASCE 7 and the New York City Building Code; however, the accelerations were somewhat above typically acceptable ranges. The primary reasons for this were that 1) at lower levels there was significant shielding from other existing buildings, reducing the loads substantially, while 2) at higher levels the structure was also subject to some buffeting from wind interacting with surrounding tall buildings.
