**SEISMIC REHABILITATION OF HISTORIC CONCRETE STRUCTURE  
WITH FLUID VISCO-ELASTIC DAMPERS**

**Kit Miyamoto, M.S., S.E., President & CEO  
Lon M. Determan, S.E., Project Manager  
Amir Gilani, Ph.D., P.E., Project Engineer  
Marr Shaffer & Miyamoto, Inc.  
West Sacramento, CA**

## **Abstract**

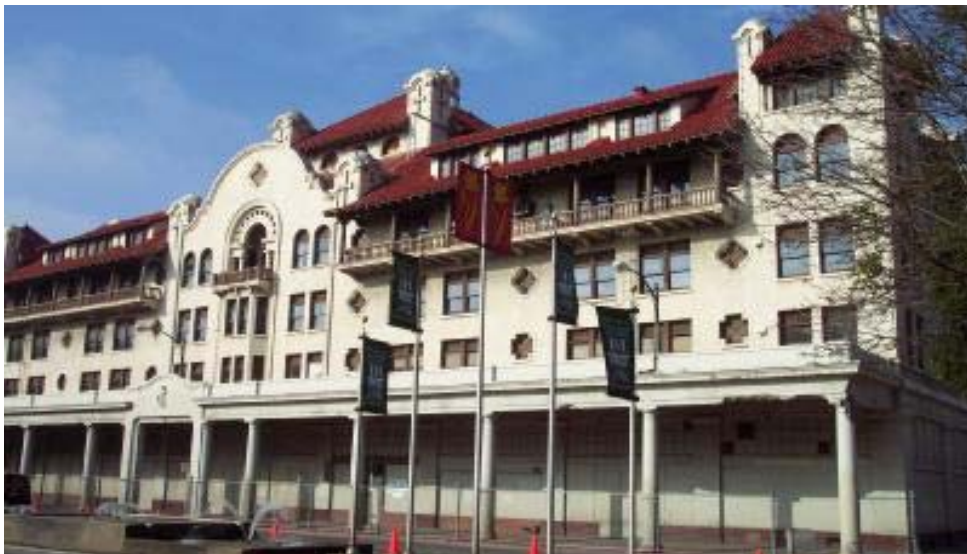
**Figure 1: South Elevation**

E-W direction and 100 ft (30.5 m) in the N-S direction. In elevation, it is comprised of a six-story portion on the east side and a two-story portion on the west side, and has a full basement. The first story is 18 ft (5.5 m) high and the remaining floors have a story height of 10'-3" (3.1 m). Figure 1 below shows a south elevation of the eastern portion of the building.

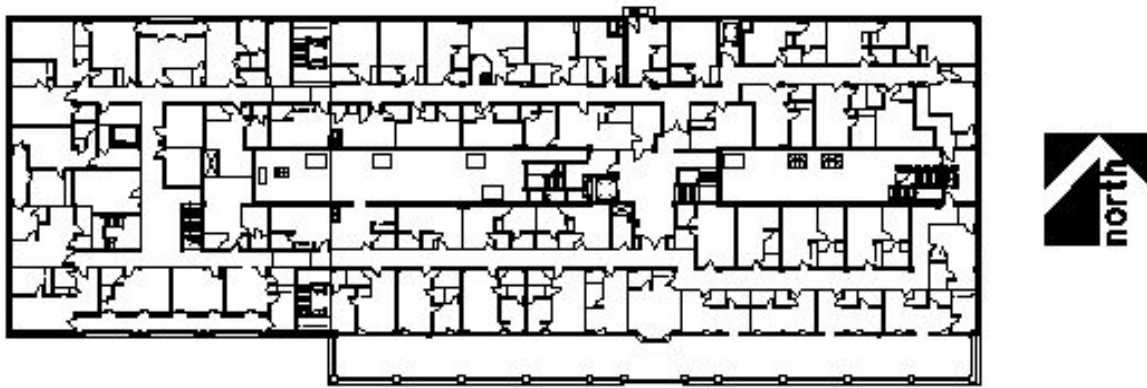
**Figure 2: Plan View at 2<sup>nd</sup> Floor**

In the E-W direction, the building consists of 15 bays at approximately 20-ft (6.1-m) spacing. In the N-S direction, there are five bays at approximately 20 ft (6.1 m) per bay, see Figure 2. The structure is a cast-in-place reinforced concrete building. Reinforced concrete columns, beams, and shear walls comprise the gravity and lateral load resisting system. The basement columns are 18- and 20-in. (457 and 508 mm) square for the two-story and six-story segments of the building, respectively. At the ground floor and above, column sizes vary from 18-in. (457 mm) square at the first story to 14-in. (356 mm) square at the fifth story. There is a full 9-in. (229 mm) thick concrete perimeter wall between the basement and the first floor, and there are numerous 6-in. (152 mm) thick concrete walls between the floors above the second floor. However, there are no structural walls between the ground and the second floor levels. Typical floors consist of 4-in. (102 mm) concrete slabs with a 2-in. (51 mm) topping slab supported by E-W concrete beams, and N-S concrete girders.

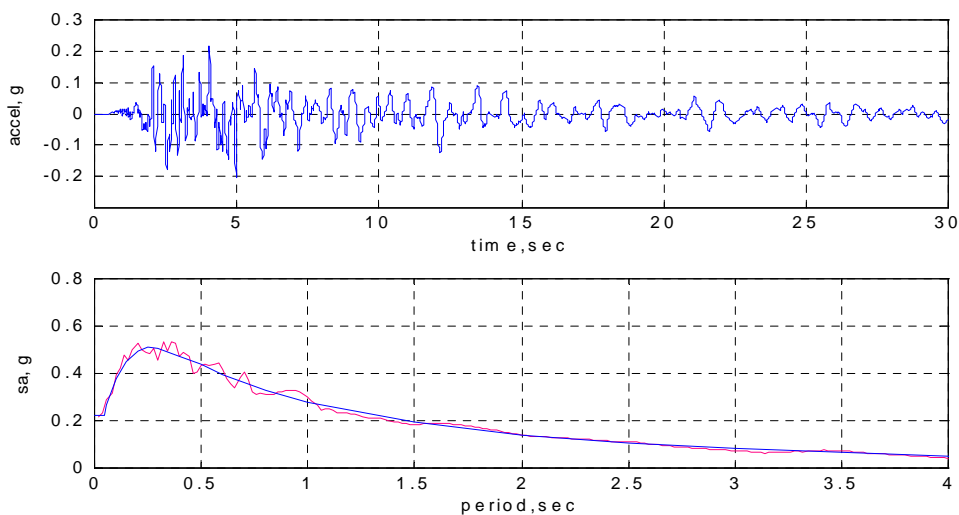
**Figure 5: Acceleration Record & Spectrum**

Agnews, 0- and 90-degree components recorded at Gilroy, and 270- and 360-degree components recorded at San Marino). Figure 5 shows the DBE acceleration record and the computed acceleration spectrum for the x-component of the Agnews record. The y-component of this record and the x- and y-components of the other two records have similar acceleration spectra.

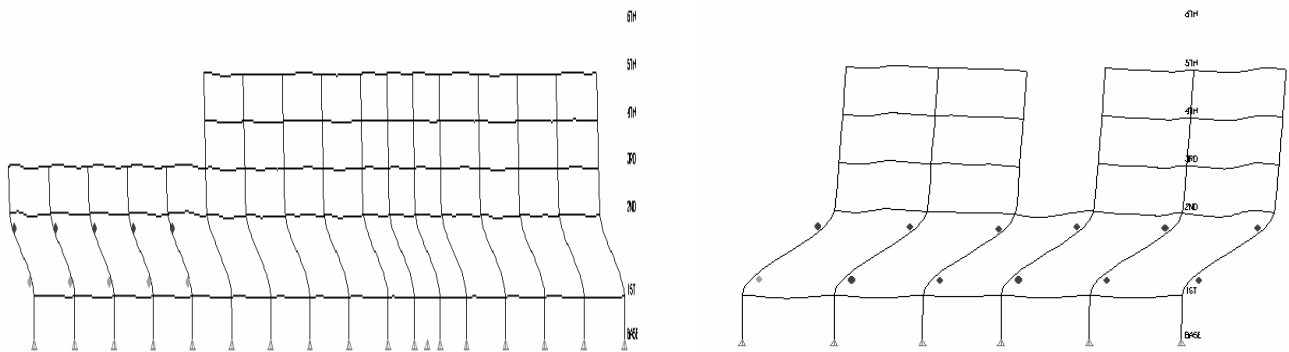
**Figure 9a & 9b: Progressive Hinge Formation (elevations)**

The displaced structure at a story displacement of 1.5 in. (38 mm) for loading along the longitudinal-axis (Figure 9a), and 2.5 in. (64 mm) for loading along the Transverse-axis are shown (Figure 9b). Note that many of the first story columns have formed plastic hinges at the top and bottom. The soft-story behavior of the

building is made clear in the figures; all the floors above the second floor have a nearly rigid behavior, while the

first story columns experience substantial deformation.

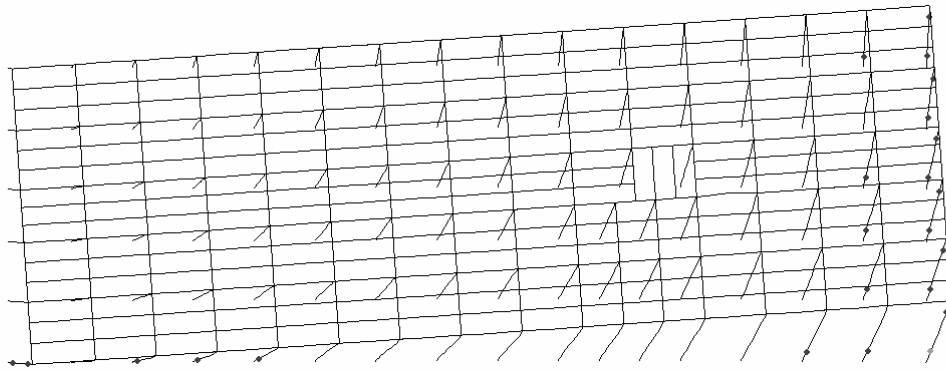
**Figure 10: Progressive Hinge Formation (Plan)**

Figure 10 shows the second floor plan view of the structure at the deformation level of 2.5 in. (64 mm) as the structure is pushed in the transverse-direction. It is noted that all the nonlinear behavior is concentrated at or close to the right (east) side of the building. As previously noted, the building is torsionally irregular in the transverse direction.

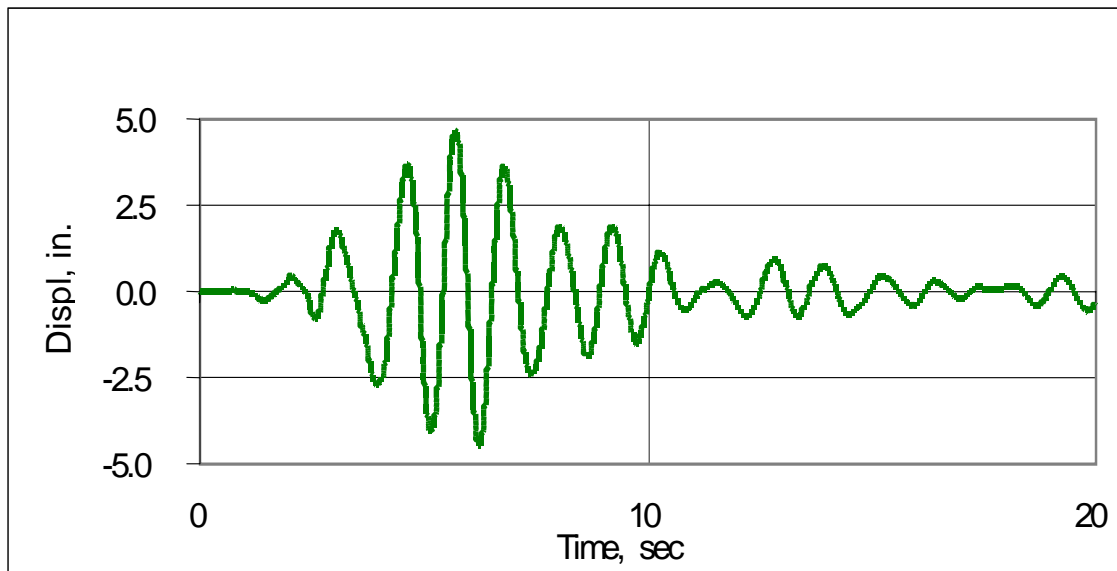
**Figure 11: Displacement History of Existing Structure (Linear Model)**

The three dimensional linear model was subjected to this accelerogram. Figure 11 shows the second floor displacements as measured at the lower-right (S.E.) corner of the building. Using equal displacement assumption, a comparison of the time history response of the existing building with that of the nonlinear pushover analysis indicates that the story drifts will cause significant plastic rotation in the hinge regions of the columns, and cause probable collapse of the building.

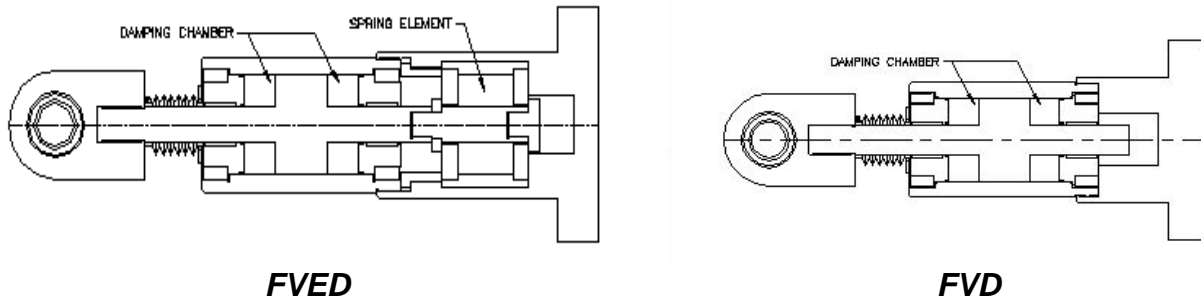
**Figure 13: FVED & FVD Devices**

See Figure 13 for FVED and FVD construction. Prototype testing per FEMA 273 will be conducted to verify response and durability.

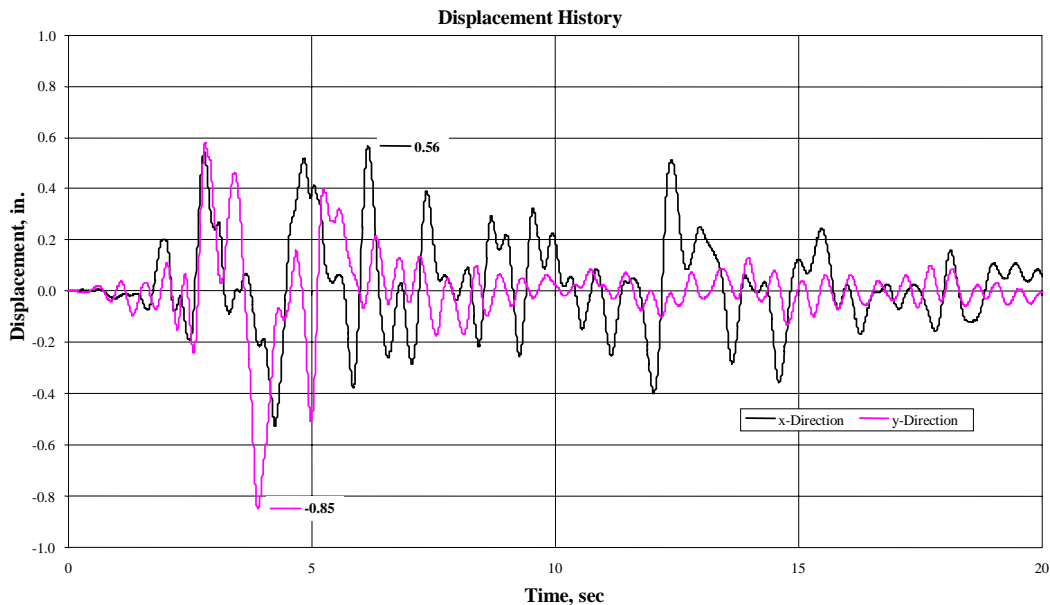
**Figure 14: Displacement History of Damped Structure**

first story columns was performed. Figure 14 shows the second floor displacement responses for the lower-right (S.E.) corner. It is noted that the maximum computed displacements are approximately 0.56 in. (14 mm) and

0.85 in. (22 mm) in the longitudinal transverse directions, respectively, which is well below their target values. This corresponds to story drift ratios of approximately 0.003 and 0.004, respectively. A comparison of the displacement response for the original structure and this figure shows that the maximum response was reduced by more than a factor of five by the addition of FVD and FVED elements.

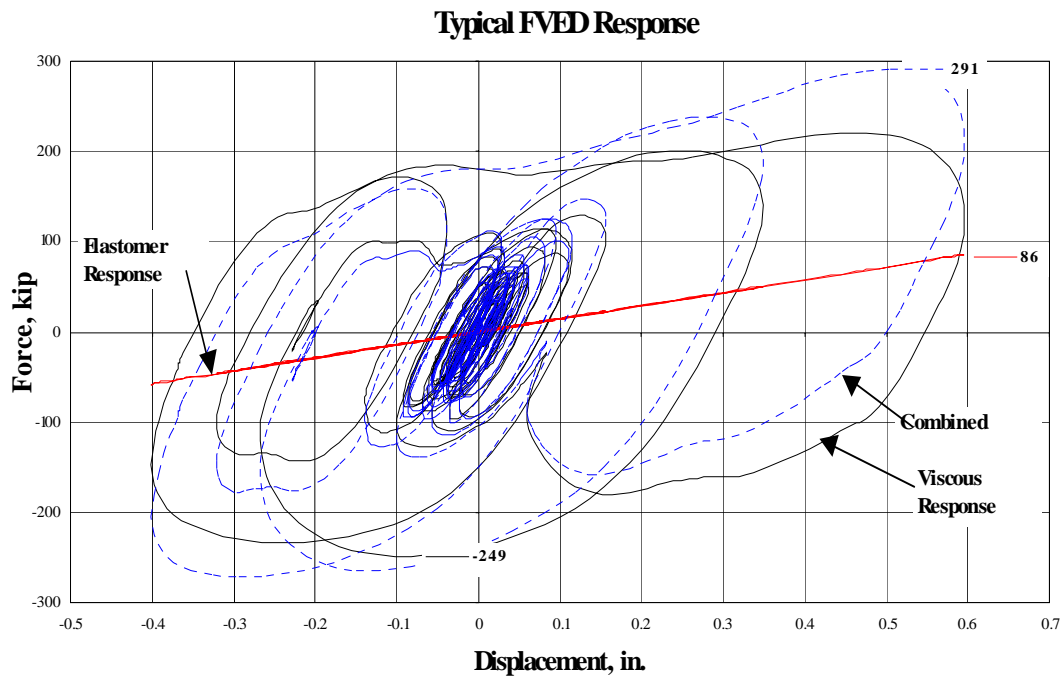
**Figure 15: Typical FVED response**

bays. Figure 15 depicts the response of a typical FVED. It is noted that the maximum damper and spring forces are approximately 250 kips (1112 kN) and 90 kips (400 kN), respectively. Spectra acceleration of this structure was 0.17g.
