**SEISMIC REHABILITATION OF HISTORIC CONCRETE STRUCTURE
WITH FLUID VISCO-ELASTIC DAMPERS**

**Kit Miyamoto, M.S., S.E., President & CEO
Lon M. Determan, S.E., Project Manager
Amir Gilani, Ph.D., P.E., Project Engineer
Marr Shaffer & Miyamoto, Inc.
West Sacramento, CA**

This paper presents the nonlinear seismic analysis, development, and implementation of an innovative seismic retrofit strategy for a six-story nonductile reinforced concrete 145,000-sf (13,470 m²) historic building. Dynamic and nonlinear static analytical results verified that the building had a weak soft-story with inadequate post-yield capacity, and large torsional response. The analysis indicated that the existing building is not seismically adequate to withstand anticipated lateral forces generated by earthquake excitations at the site. A “collapse prevention” performance upgrade for a 475-year return event was desired. Nonlinear fluid viscous dampers were placed at the first story level to reduce the seismic demand and obtain a more uniform response. Visco-elastic fluid viscous dampers were strategically placed at one side of the building to reduce the torsional irregularity of the building. The proposed cost e

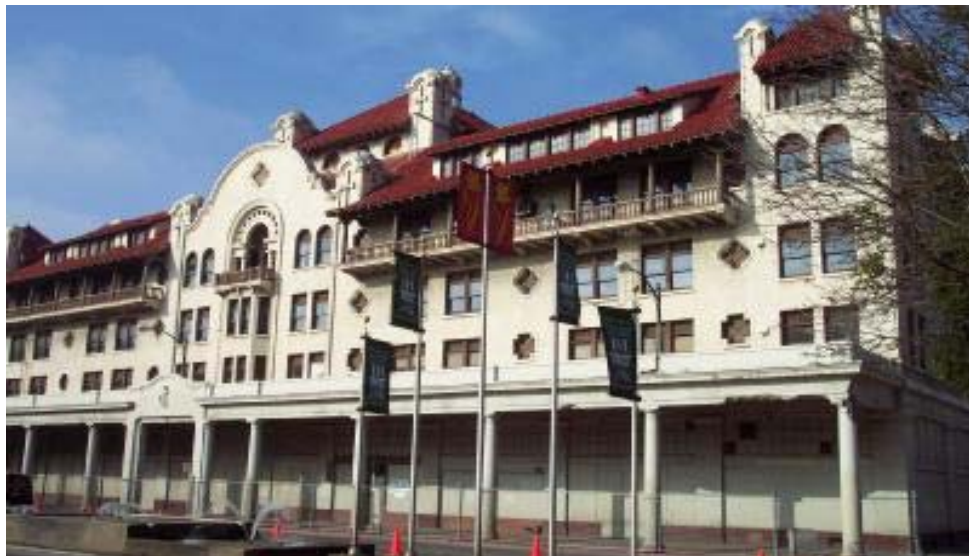
Figure 1: South Elevation

E-W direction and 100 ft (30.5 m) in the N-S direction. In elevation, it is comprised of a six-story portion on the east side and a two-story portion on the west side, and has a full basement. The first story is 18 ft (5.5 m) high and the remaining floors have a story height of 10'-3" (3.1 m). Figure 1 below shows a south elevation of the eastern portion of the building.

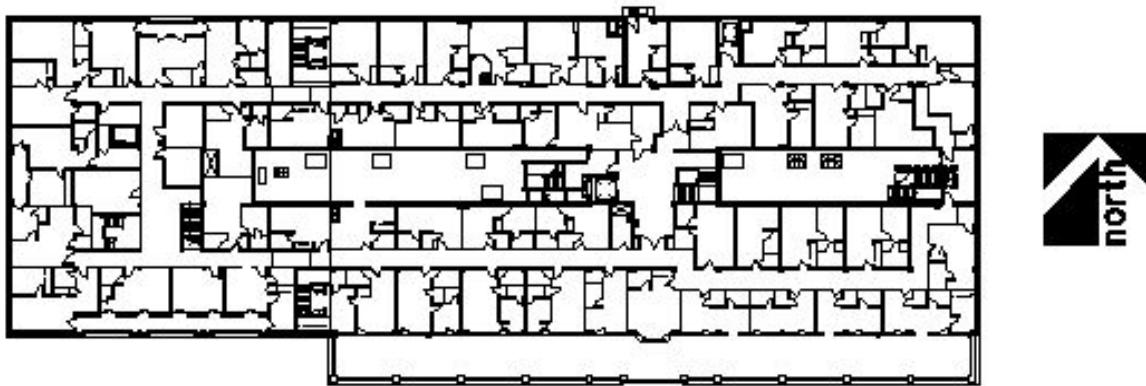
Figure 2: Plan View at 2nd Floor

In the E-W direction, the building consists of 15 bays at approximately 20-ft (6.1-m) spacing. In the N-S direction, there are five bays at approximately 20 ft (6.1 m) per bay, see Figure 2. The structure is a cast-in-place reinforced concrete building. Reinforced concrete columns, beams, and shear walls comprise the gravity and lateral load resisting system. The basement columns are 18- and 20-in. (457 and 508 mm) square for the two-story and six-story segments of the building, respectively. At the ground floor and above, column sizes vary from 18-in. (457 mm) square at the first story to 14-in. (356 mm) square at the fifth story. There is a full 9-in. (229 mm) thick concrete perimeter wall between the basement and the first floor, and there are numerous 6-in. (152 mm) thick concrete walls between the floors above the second floor. However, there are no structural walls between the ground and the second floor levels. Typical floors consist of 4-in. (102 mm) concrete slabs with a 2-in. (51 mm) topping slab supported by E-W concrete beams, and N-S concrete girders.

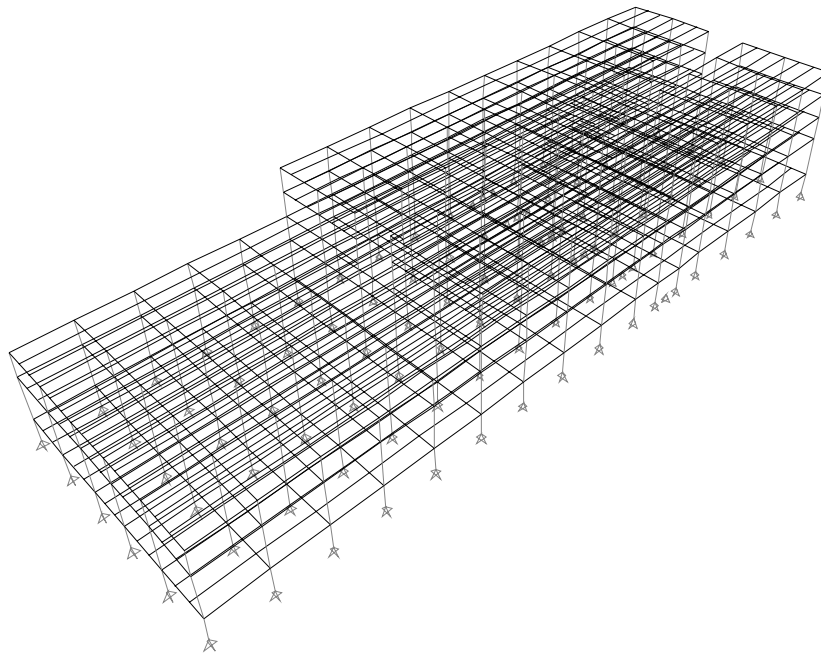
Figure 3: Schematic of The Mathematical Model of The Building

The computer program ETABS (CSI 2001) was used to prepare a mathematical model of the building, see Figure 3 for a schematic of the model. Key features of the mathematical model are summarized below.

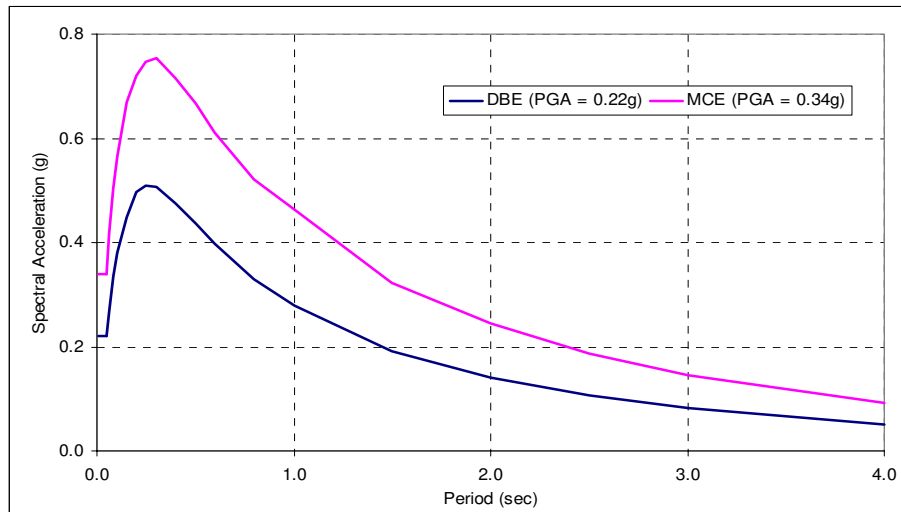
Figure 4: Response Spectra

exceedence in 50 years) used for the studies presented herein is shown in Figure 4. In the same plot, the response spectrum for the Maximum Considered Earthquake (MCE) (2% probability of exceedence in 50 years) is also shown.

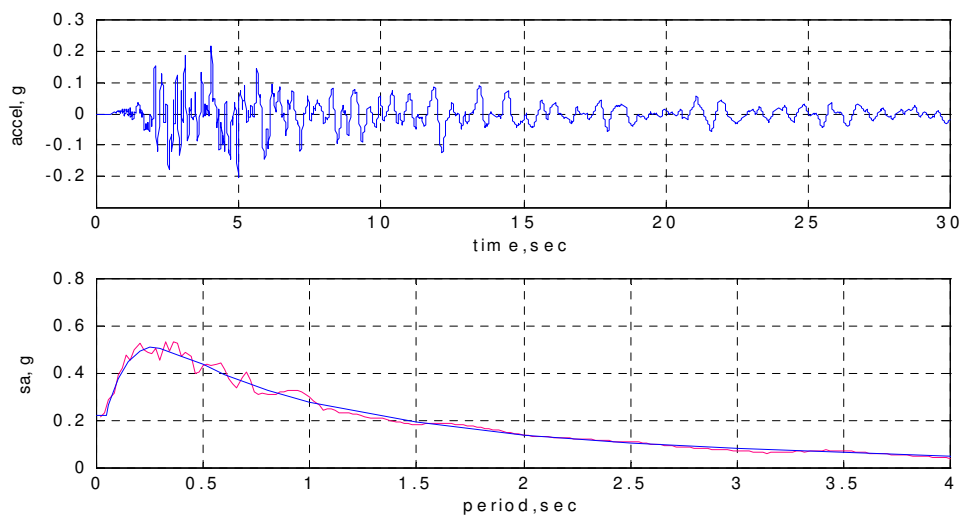
Figure 5: Acceleration Record & Spectrum

Agnews, 0- and 90-degree components recorded at Gilroy, and 270- and 360-degree components recorded at San Marino). Figure 5 shows the DBE acceleration record and the computed acceleration spectrum for the x-component of the Agnews record. The y-component of this record and the x- and y-components of the other two records have similar acceleration spectra.

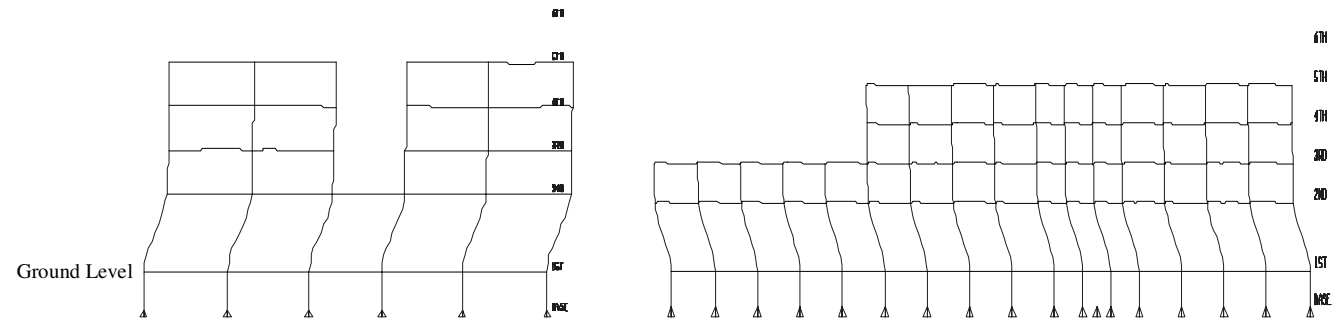
Figure 6: Modes 1 & 2 (Elevations)

Dynamic analysis. A modal analysis of the building was conducted to determine the fundamental period and mode shapes of the structure. Table 1 summarizes the results for the first three modes obtained. The first two mode shapes of the building are shown in Figure 6a and 6b. It is noted that the response is that of a soft-story structure with nearly all the deformation concentrated in the first story columns.

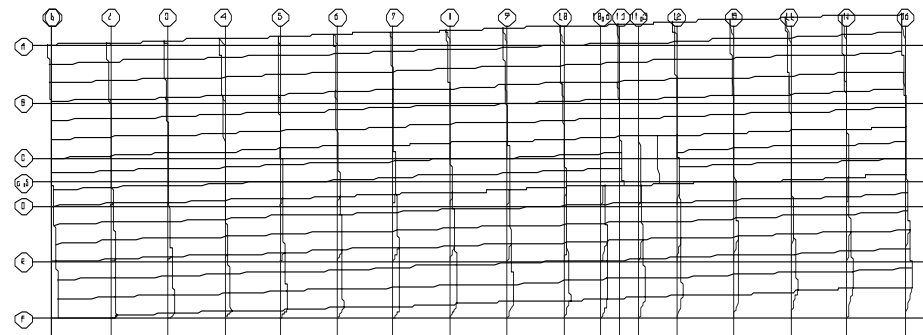
Figure 7: Mode 1 (Plan)

torsional component to this mode. In particular, the largest deformation occurs at the far right (east) side of the building. This torsional response will place additional demand on the columns at this side of the structure.

Figure 7 shows the deformed shape of the second floor in plan for the first mode. It is noted that due to the lack of symmetry in the N-S direction, there is a large

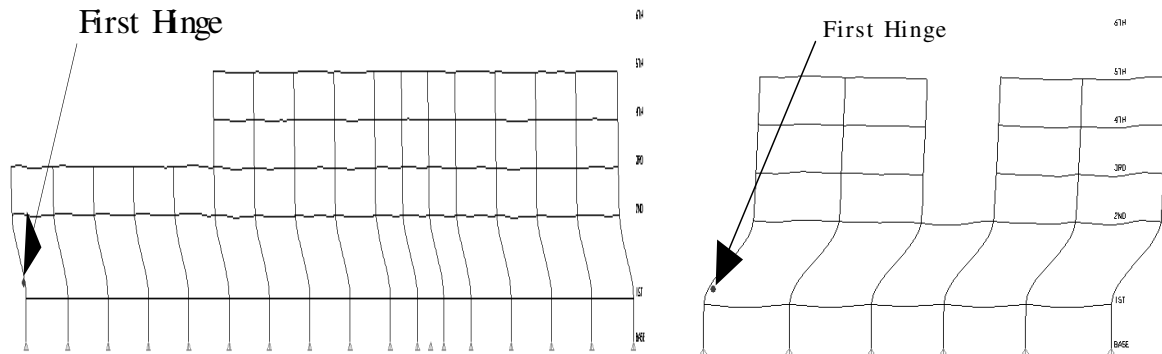
Figure 8: Hinge Initiation

Two particular events of interest were studied: (1) when does the first plastic hinge form in each direction, and (2) what is the ultimate configuration of the plastic hinge? (The plastic hinges are identified by circles on the columns.) The displaced shape of the structure at the formation of the first column plastic hinge is shown in Figure 8. The frame elevation on the left corresponds to

the formation of the first plastic hinge when the structure is pushed along the longitudinal-direction. This yielding

response occurs at a displacement of 0.84 in. (21 mm), measured at the second floor level. The frame elevation on the right corresponds to the formation of the first plastic hinge when the structure is pushed along the transverse-direction. This yielding response occurs at a displacement of 1.44 in. (37 mm), measured at the right (east) side of the second floor level. In summary, as long as the second floor displacements are limited to the values specified above, it is expected that the column response for the critical first story columns will remain in the elastic range.

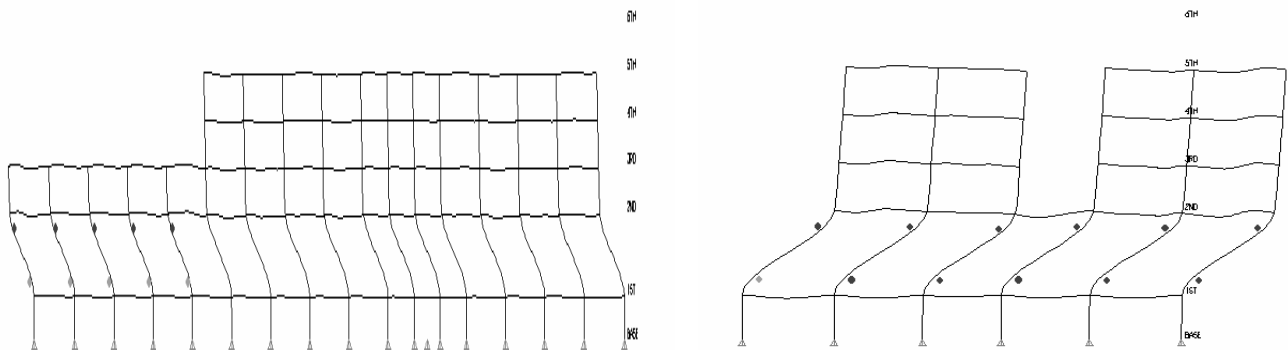
Figure 9a & 9b: Progressive Hinge Formation (elevations)

The displaced structure at a story displacement of 1.5 in. (38 mm) for loading along the longitudinal-axis (Figure 9a), and 2.5 in. (64 mm) for loading along the Transverse-axis are shown (Figure 9b). Note that many of the first story columns have formed plastic hinges at the top and bottom. The soft-story behavior of the

building is made clear in the figures; all the floors above the second floor have a nearly rigid behavior, while the

first story columns experience substantial deformation.

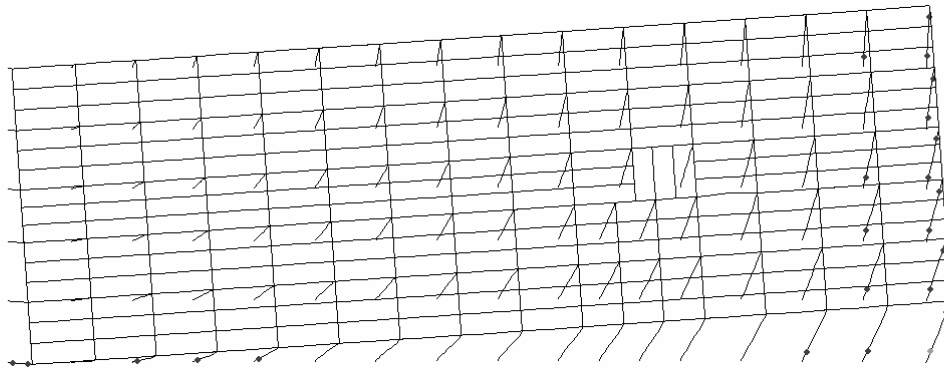
Figure 10: Progressive Hinge Formation (Plan)

Figure 10 shows the second floor plan view of the structure at the deformation level of 2.5 in. (64 mm) as the structure is pushed in the transverse-direction. It is noted that all the nonlinear behavior is concentrated at or close to the right (east) side of the building. As previously noted, the building is torsionally irregular in the transverse direction.

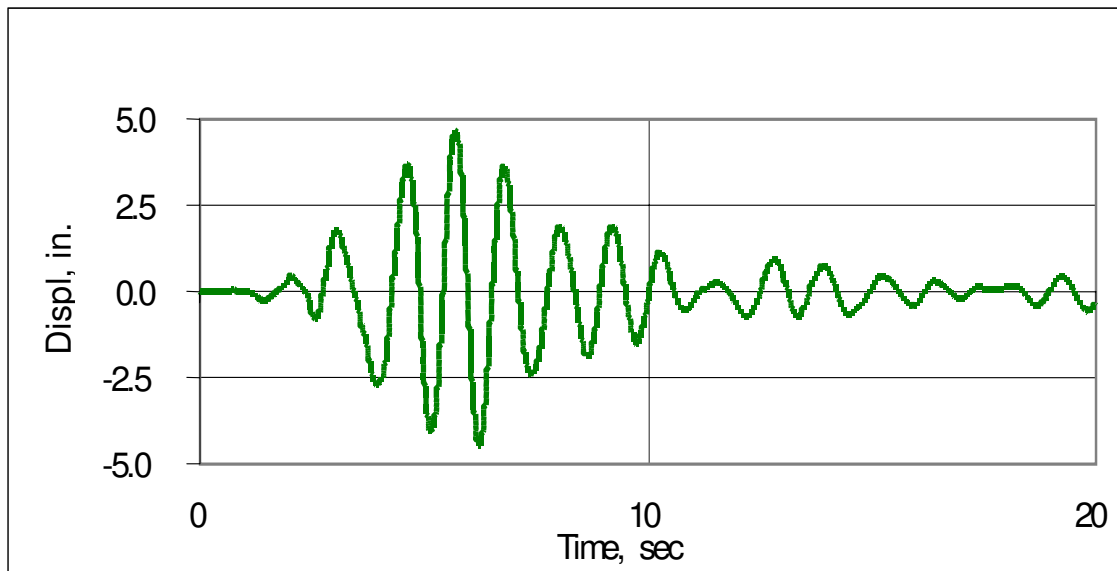
Figure 11: Displacement History of Existing Structure (Linear Model)

The three dimensional linear model was subjected to this accelerogram. Figure 11 shows the second floor displacements as measured at the lower-right (S.E.) corner of the building. Using equal displacement assumption, a comparison of the time history response of the existing building with that of the nonlinear pushover analysis indicates that the story drifts will cause significant plastic rotation in the hinge regions of the columns, and cause probable collapse of the building.

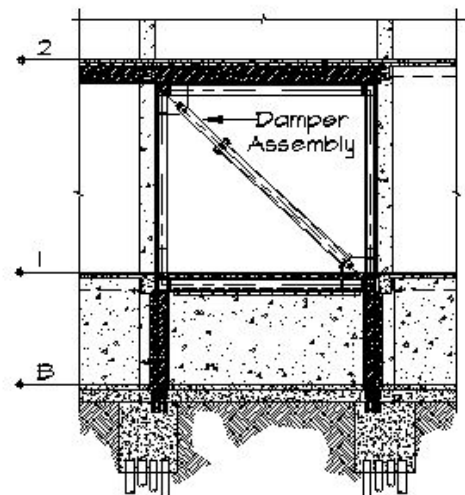
Figure 12: Damper Frame Elevation

Additional columns at either end of the diagonal devices will prevent the transfer of the damper forces to the existing building columns. Figure 12 shows a typical damper frame elevation.

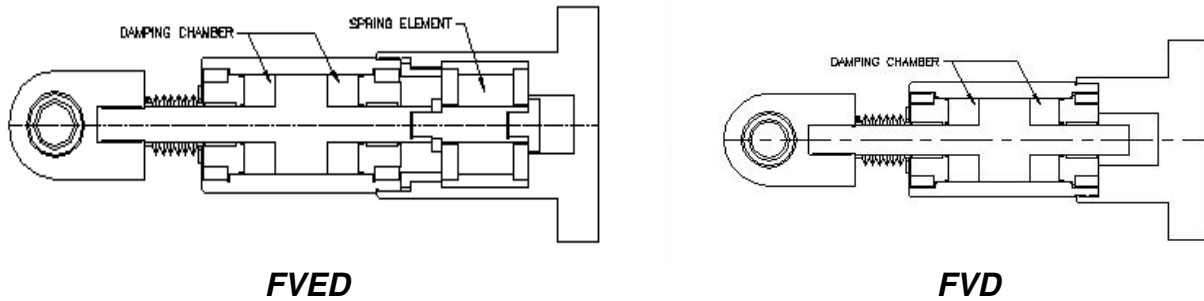
Figure 13: FVED & FVD Devices

See Figure 13 for FVED and FVD construction. Prototype testing per FEMA 273 will be conducted to verify response and durability.

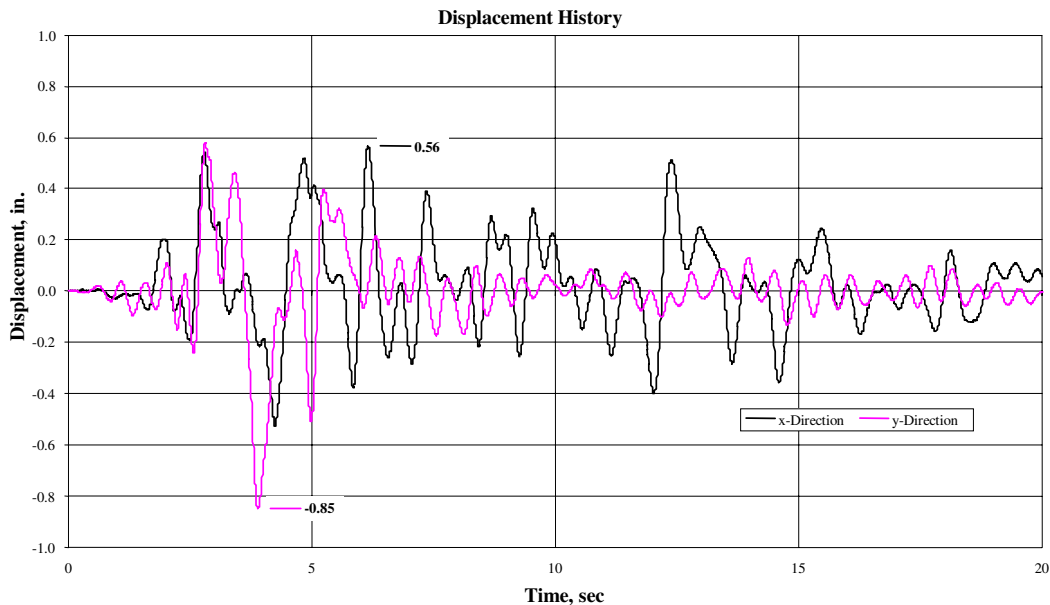
Figure 14: Displacement History of Damped Structure

first story columns was performed. Figure 14 shows the second floor displacement responses for the lower-right (S.E.) corner. It is noted that the maximum computed displacements are approximately 0.56 in. (14 mm) and

0.85 in. (22 mm) in the longitudinal transverse directions, respectively, which is well below their target values. This corresponds to story drift ratios of approximately 0.003 and 0.004, respectively. A comparison of the displacement response for the original structure and this figure shows that the maximum response was reduced by more than a factor of five by the addition of FVD and FVED elements.

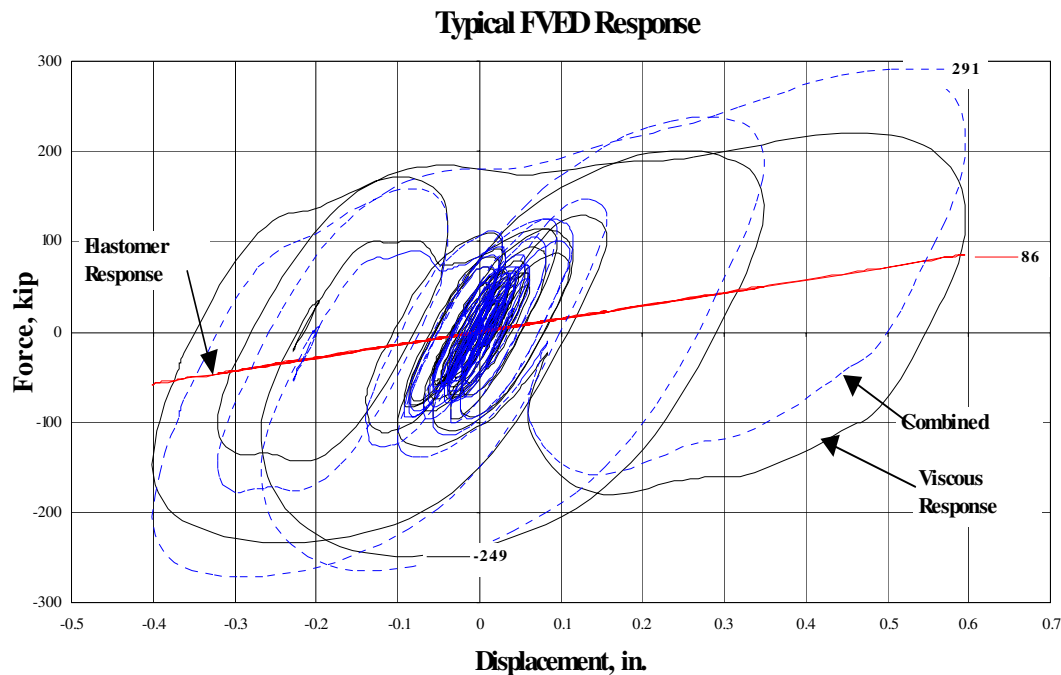
Figure 15: Typical FVED response

bays. Figure 15 depicts the response of a typical FVED. It is noted that the maximum damper and spring forces are approximately 250 kips (1112 kN) and 90 kips (400 kN), respectively. Spectra acceleration of this structure was 0.17g.
