## **TORSIONAL CONTROL OF TWO ADJACENT OFFICE BUILDINGS USING VISCOUS DAMPERS**

### **Abstract**

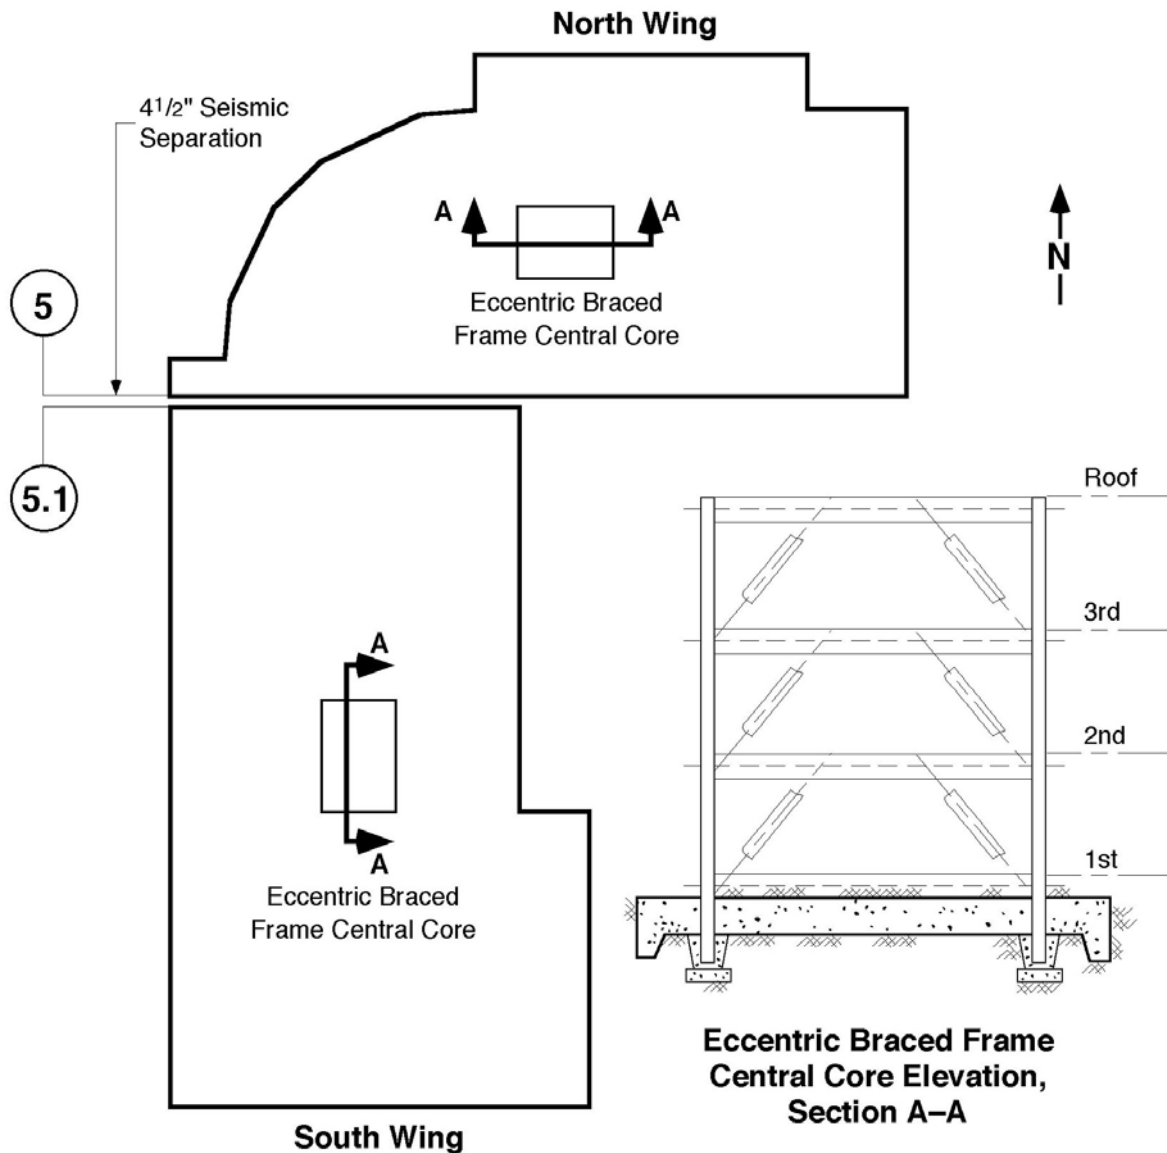
Figure 1. Typical Floor Plan

**Building Description.** The three story steel frame office building was configured as two rectangles to produce an ‘L’ shaped building plan as shown in Figure 1. The overall plan dimensions were 306’ x 214’ with a total enclosed floor area of 105,000 square feet.

**Structural Weakness.** When torsional irregularity was reviewed under the 1988 UBC seismic design provisions, the lateral load resisting bracing system was found to be overstressed. Worse yet, lack of adequate torsional stiffness resulted in horizontal floor and roof deflections at the 4 ½ inch seismic separation joint (See Figure 1) under code design loads that exceeded the separation space by a factor of 4. This meant

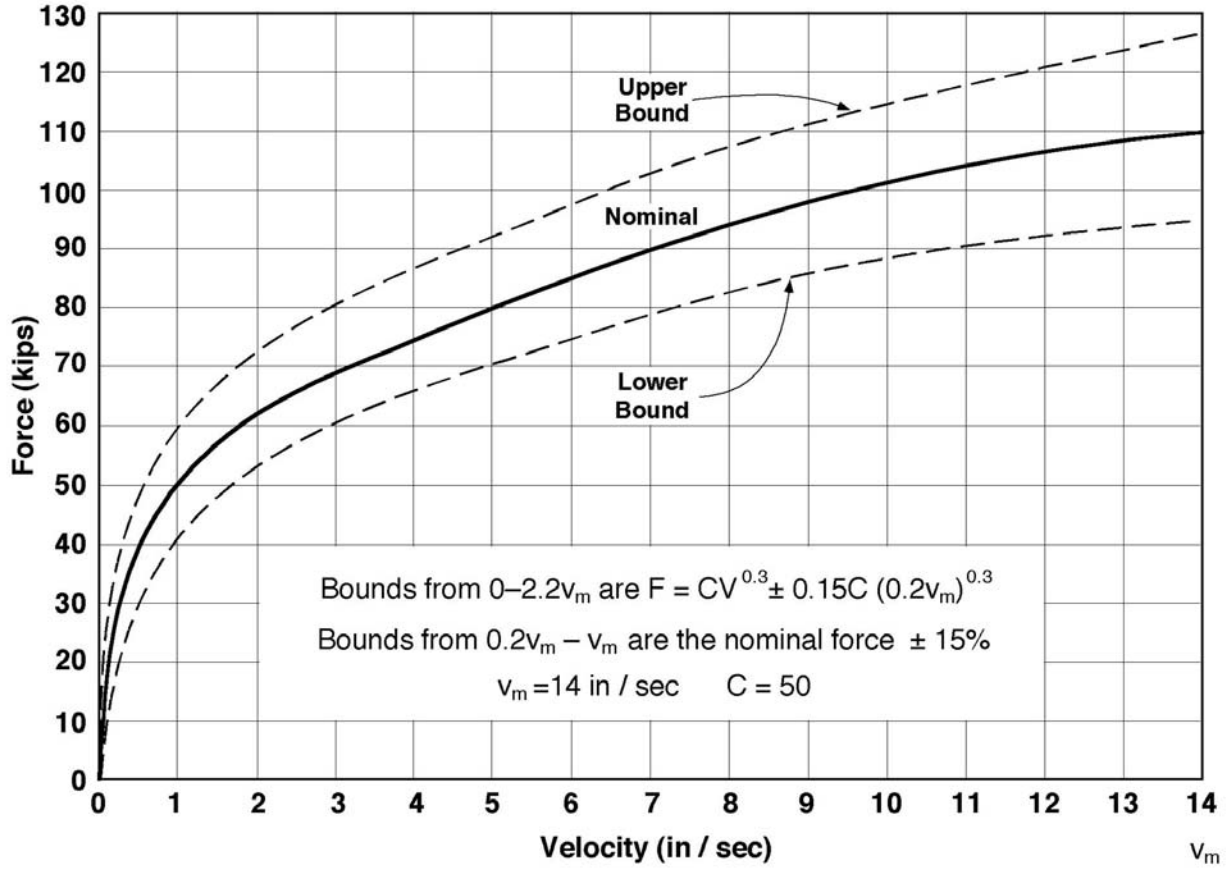
Figure 2. Force - Velocity Envelope For Damper Design

Nonlinear viscous damper elements were explicitly incorporated into the model with properties optimized using various trial force-velocity relationships, resulting in the final relationship of  $F = CV^a$  where  $C = 50$  and

$\alpha=0.3$ , see Figure 2. Global viscous damping was modeled as seven percent. This value was reasonable because at the Maximum Capable Earthquake (MCE), a 950-year return period event, elements of the lateral force resisting system are at or near yield and significant soil passive deformation at the mat footings is expected.

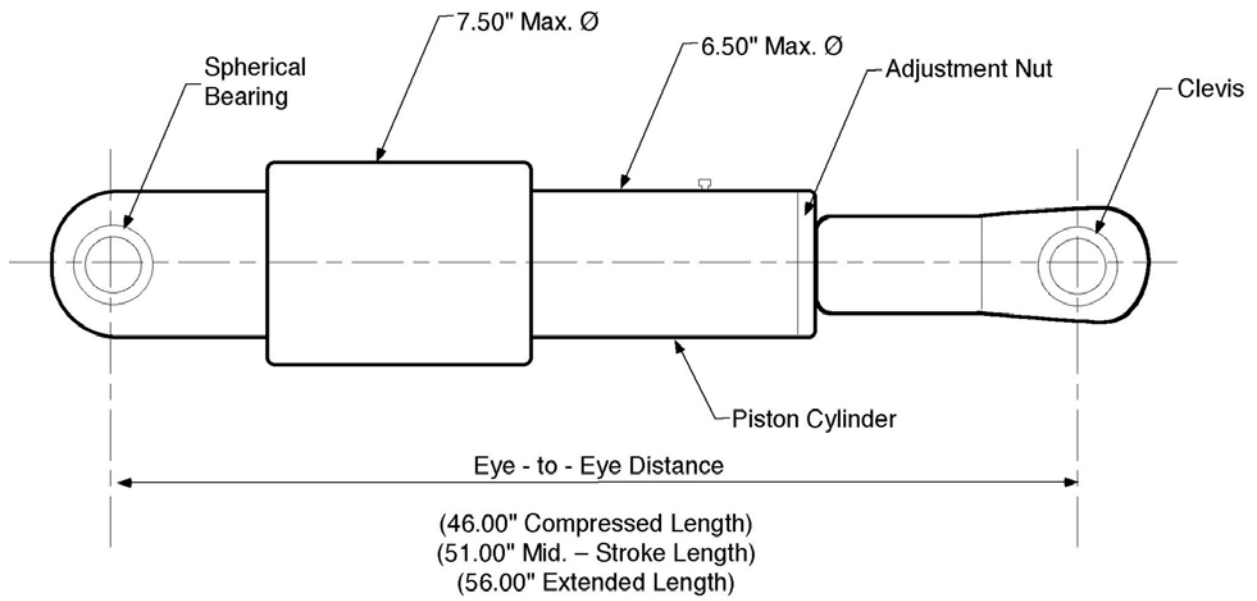
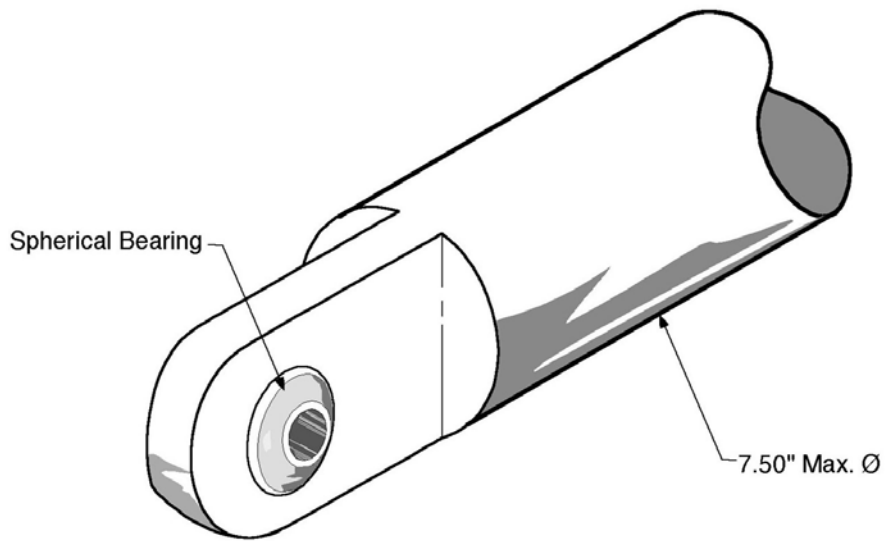
*Figure 3. Viscous Fluid Damper*

**Fluid Viscous Damper Description.** The fluid viscous damper used in the structure retrofit is similar in action to the shock absorber on an automobile, but operates at a much higher force level. The damper used in structures is significantly larger than an automotive damper (see Figure 3). It is constructed of stainless steel and other extremely durable materials as required to furnish a life expectancy of at least 35 years. The damping fluid is silicone oil, which is inert, non-flammable, non-toxic, and stable for extremely long periods of time. The seals in the fluid viscous damper provide leak free service. This design has been proven through rigorous testing and has been in use for over 45 years.

Spherical bearings at each end of the fluid viscous damper permit the damper to angulate relative to the structure without binding. Figure 3 shows a detail of these spherical end bearings. These bearings permit rotation in every direction, which prevents binding in the fluid viscous damper.

**Geometry Of Viscous Fluid Damper**

**Spherical Bearing**

The damping action is provided by the flow of fluid across the piston head. The piston head is made with a deliberate clearance between the inside of the cylinder and the outside of the piston head, which forms an annular orifice. The fluid flows through this orifice at high speed as the damper strokes. The shape of the piston head determines the damping characteristics. The force vs. velocity relationship for this kind of damper can be characterized as  $F=CV^\alpha$ , where  $F$  is the output force in pounds,  $V$  is the relative velocity across the damper in inches per second,  $C$  is a constant determined mainly by the damper diameter and the orifice area, and exponent  $\alpha$  is a constant which can be any value from 0.30 to 1.95. The exact value for  $\alpha$  depends upon the shape of the piston head. Values for  $\alpha$  ranging from 0.3 to 1.0 seem to work best for structural applications.

Installation of the dampers was relatively easy, requiring two men and a portable hoist, and taking less than one hour per damper. The dampers have a ball type fitting at each end as shown in Figure 3, which provides angular freedom about the three axes, keeping the damper from experiencing moment loading when the two buildings twist relative to each other. These fittings made it easy to slip the damper into the supporting yoke and insert the large mounting pins through the holes in the yoke and ball fitting. The mounting pins were secured from falling out of the clevis connection with washers and cotter pins.

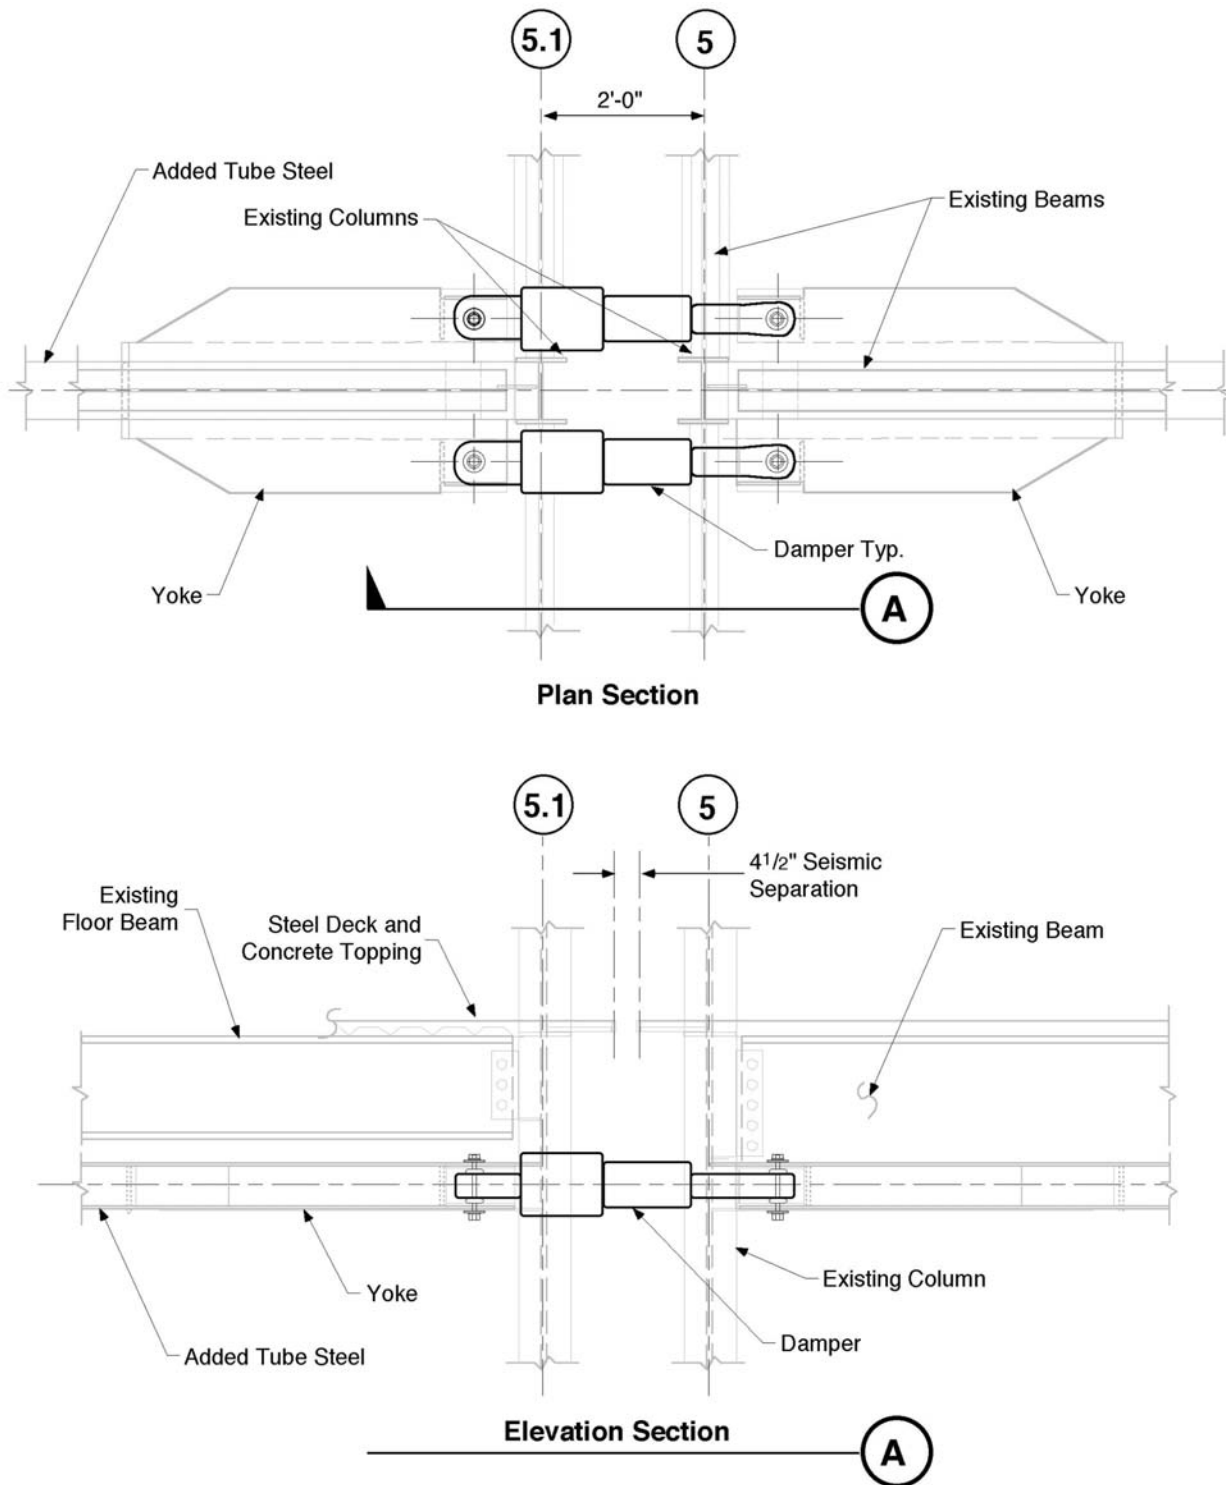
Figure 4. Typical Damper Installation

Figures 4 and 5 illustrate the typical damper and shear key installations along the seismic separation joint at lines 5 and 5.1. Two dampers were installed, one on either side of the main interior columns at the seismic joint as shown in the top of Figure 4. A single damper was installed at the exterior column at the re-entrant corner. The dampers were installed in a specially fabricated yoke of added tube steel, used to transfer the high concentrated axial forces in the dampers around the columns at the seismic joint and back into the structural framing system of the floor.

**Structural Modifications.** Seven viscous dampers were installed at the third floor seismic separation joint between Column lines 5 and 5.1 which served to tie the North and South Wings together as one building. These provided an axial force in tension and/or compression that acted perpendicular to the seismic joint. The shear forces developed between the two building wings at the third floor seismic separation joint were resisted by steel tube shear keys.
