**DAMPER RETROFIT OF THE LONDON MILLENNIUM
FOOTBRIDGE – A CASE STUDY IN BIODYNAMIC DESIGN**

**Douglas P. Taylor, President
Taylor Devices, Inc.
90 Taylor Drive
North Tonawanda, NY 14120-0748**

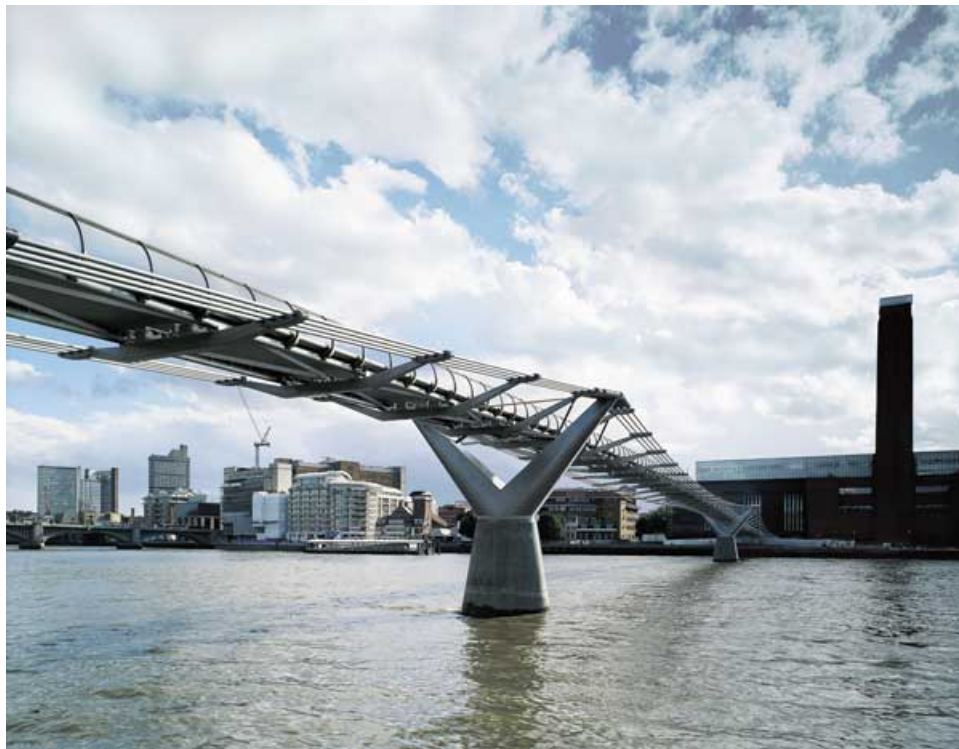
**FIGURE 1
THE MILLENNIUM BRIDGE**

The bridge design team elected to use lateral suspension cables, where the cables are located at the level of the bridge deck. Two piers are located in the river, with a main span of 144 m between piers, and end spans of 81 m on the north and 108 m on the south. The bridge deck is 4 m wide, and uses articulated sliding joints spaced at regular intervals along its length. The architectural design theme for the Millennium Bridge is that of a “Blade of Light”; expressed and exemplified by the slender, ribbon-like cross section of the structure. A photograph of the bridge is provided as Figure 1.

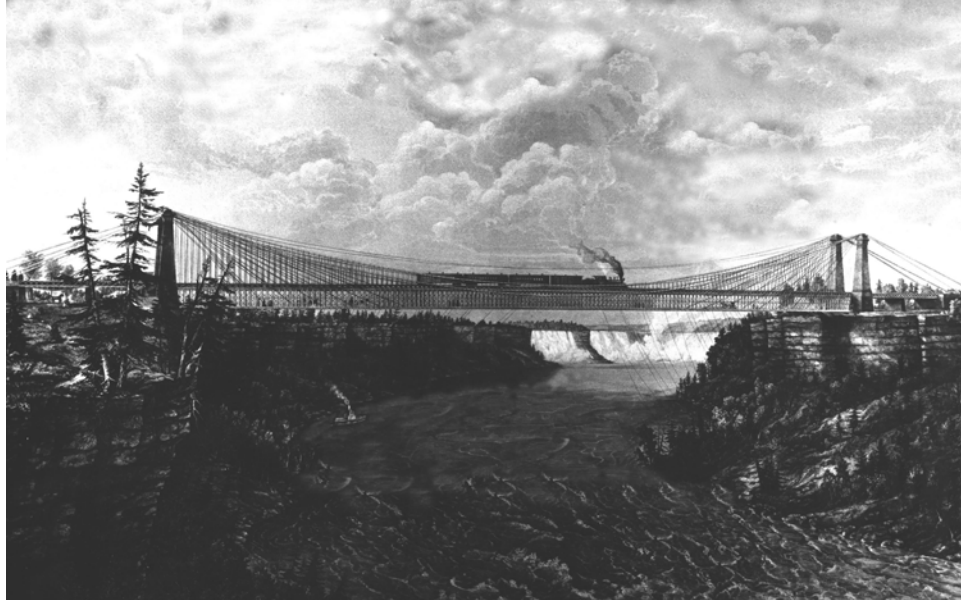
FIGURE 2
JOHN ROEBLING'S RAILWAY SUSPENSION BRIDGE AT NIAGARA FALLS, NY – 1854

The phenomena of forced harmonic excitation of bridge structures is well understood, and has been well documented by many sources. Most military manuals dating back well into the 1800’s have warnings about soldiers marching in step over bridges of any type. This was true even for substantial bridges. For example, in 1860 the famous 1854 Roebling two-deck railway suspension bridge across the Niagara River at Niagara Falls, NY USA was posted with a warning notice to pedestrians against walking in-step. This heavily built, record-setting span is depicted in Figure 2, from an 1850’s engraving. The warning notice, reproduced from period photographs, is shown in Figure 3.

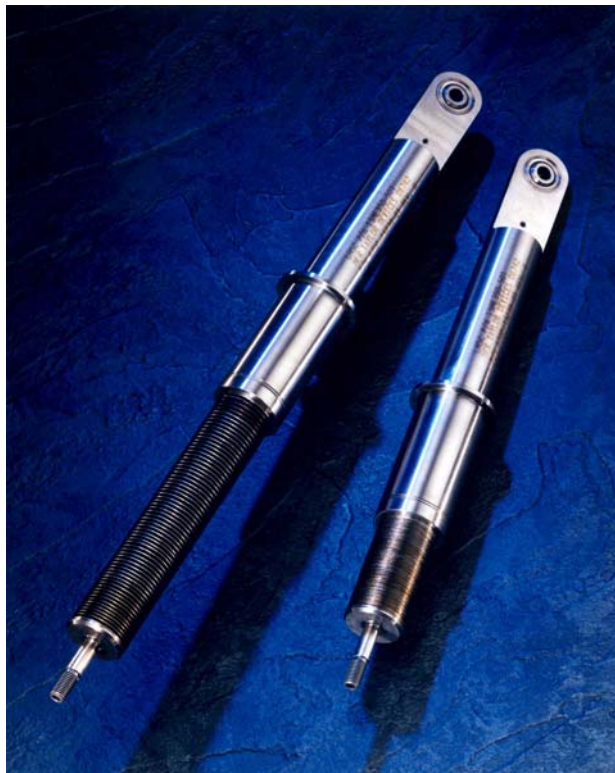
FIGURE 4
SPACE SATELLITE DAMPER

Taylor Devices, a 50 year old manufacturer of damping products, proposed a unique solution to the damper design requirements for the Millennium Bridge. To address the various design issues, a unique and patented damper was proposed, previously used exclusively by NASA and other U.S. Government agencies for space based optical systems. These previous applications had similar requirements for long life and high resolution at low amplitudes, but required relatively low damper forces from small, lightweight design envelopes. Figure 4 is a photograph of a typical damper of this design, used in space on more than 70 satellites to protect delicate solar array panels. Figure 4 also shows the most unique element of this design, a frictionless seal made from a welded metal bellows. This type of seal does not slide, but rather flexes without hysteresis as the damper moves.

To adapt this basic design to the Millennium Bridge largely involved simply scaling the small satellite dampers to the required size range. All parts, including the metal bellows, were designed with low stress levels to provide an endurance life in excess of 2×10^9 cycles. The metal bellows and other moving parts were constructed from stainless steel for corrosion resistance.

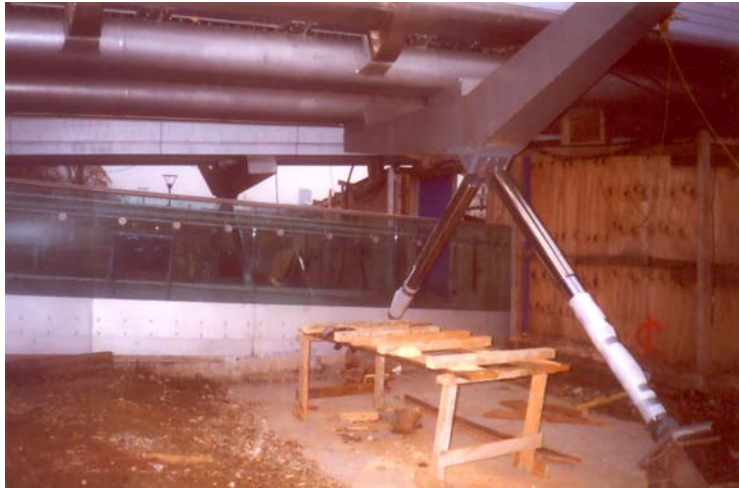
**FIGURE 7
VERTICAL DAMPERS**

All dampers were fabricated and delivered to the bridge site in 2001, and testing of the structure with groups of pedestrians began in January 2002. Figures 7 through 9 are a sampling of the installed dampers.
