## **TORSIONAL CONTROL OF TWO ADJACENT OFFICE BUILDINGS USING VISCOUS DAMPERS**

### **Abstract**

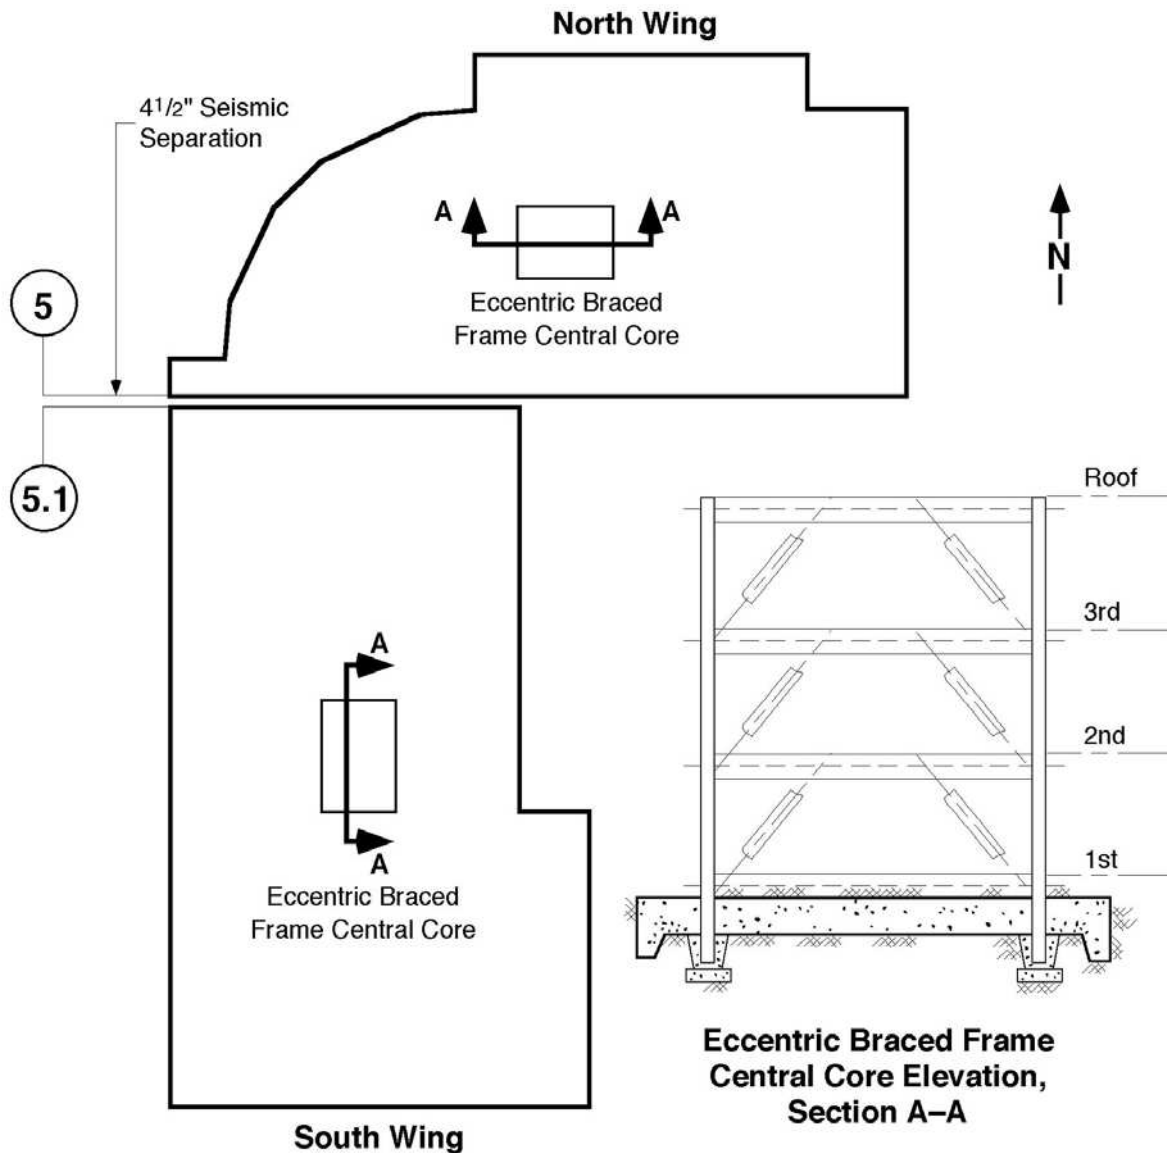
**Building Description.** The three story steel frame office building was configured as two rectangles to produce an ‘L’ shaped building plan as shown in Figure 1. The overall plan dimensions were 306’ x 214’ with a total enclosed floor area of 105,000 square feet.

Figure 1. Typical Floor Plan

**Structural Weakness.** When torsional irregularity was reviewed under the 1988 UBC seismic design provisions, the lateral load resisting bracing system was found to be overstressed. Worse yet, lack of adequate torsional stiffness resulted in horizontal floor and roof deflections at the 4 ½ inch seismic separation joint (See Figure 1) under code design loads that exceeded the separation space by a factor of 4. This meant

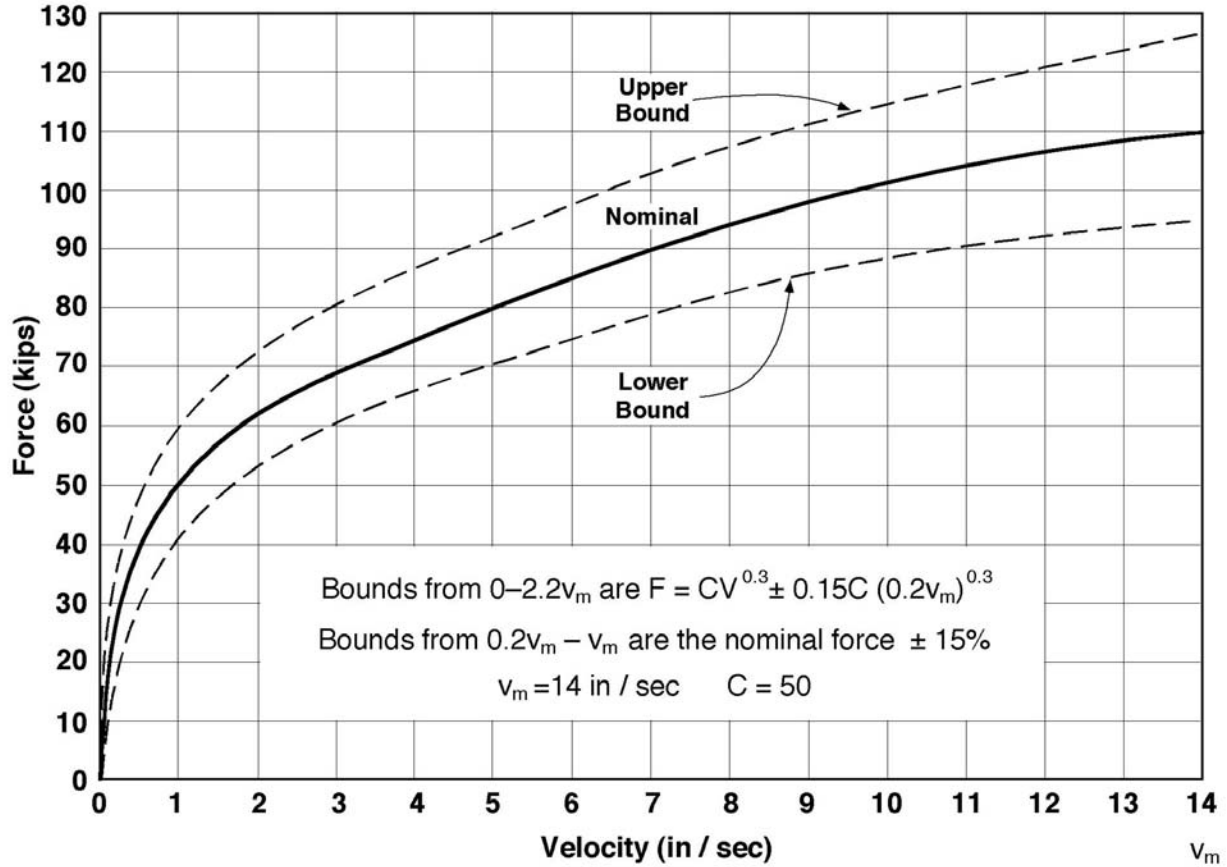
Nonlinear viscous damper elements were explicitly incorporated into the model with properties optimized using various trial force-velocity relationships, resulting in the final relationship of  $F = CV^a$  where  $C = 50$  and

$\alpha=0.3$ , see Figure 2. Global viscous damping was modeled as seven percent. This value was reasonable because at the Maximum Capable Earthquake (MCE), a 950-year return period event, elements of the lateral force resisting system are at or near yield and significant soil passive deformation at the mat footings is expected.

Figure 2. Force - Velocity Envelope For Damper Design

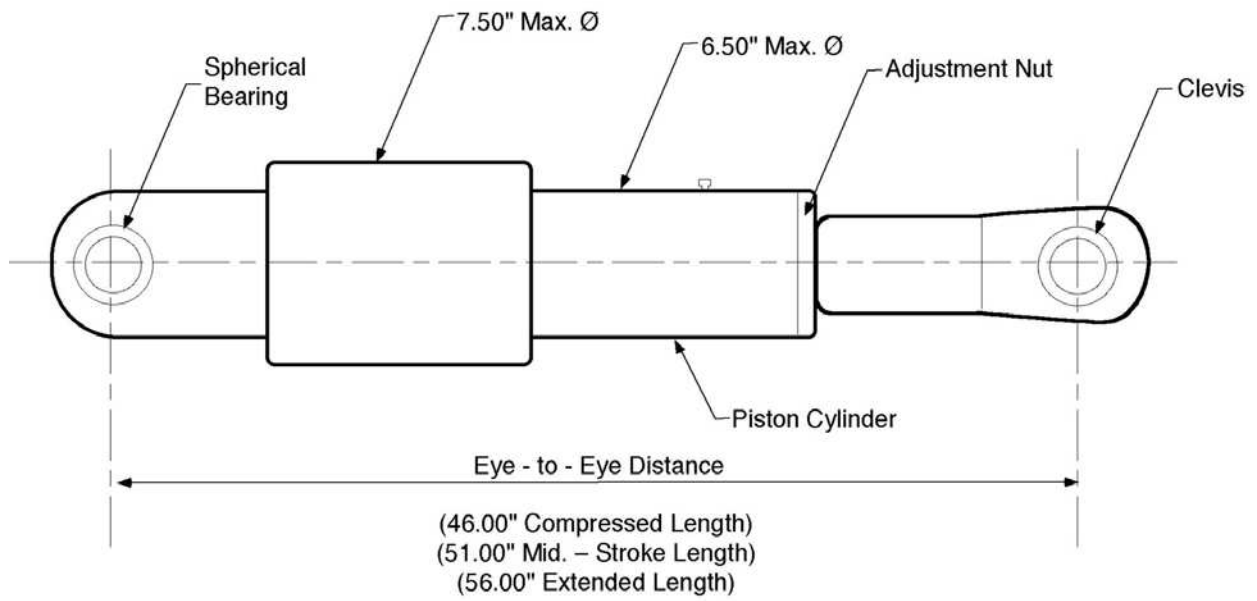
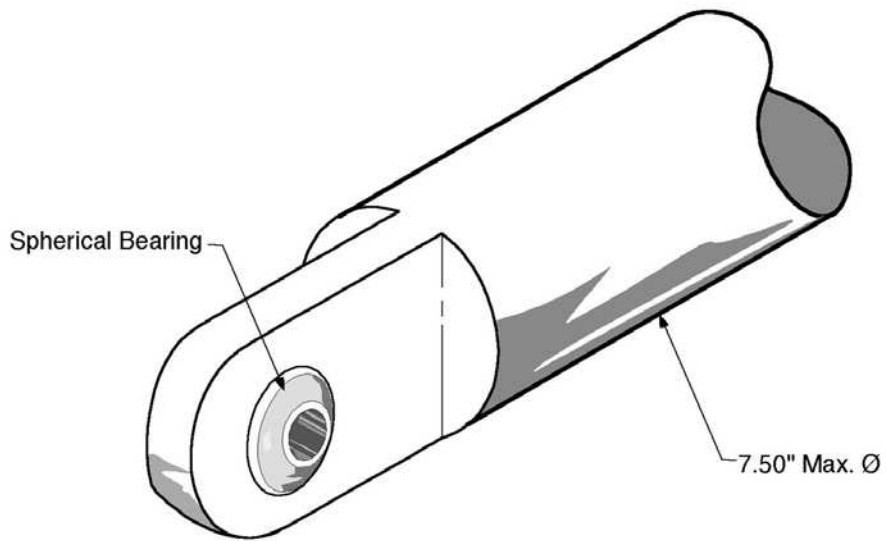
**Fluid Viscous Damper Description.** The fluid viscous damper used in the structure retrofit is similar in action to the shock absorber on an automobile, but operates at a much higher force level. The damper used in structures is significantly larger than an automotive damper (see Figure 3). It is constructed of stainless steel and other extremely durable materials as required to furnish a life expectancy of at least 35 years. The damping fluid is silicone oil, which is inert, non-flammable, non-toxic, and stable for extremely long periods of time. The seals in the fluid viscous damper provide leak free service. This design has been proven through rigorous testing and has been in use for over 45 years.

Spherical bearings at each end of the fluid viscous damper permit the damper to angulate relative to the structure without binding. Figure 3 shows a detail of these spherical end bearings. These bearings permit rotation in every direction, which prevents binding in the fluid viscous damper.

**Geometry Of Viscous Fluid Damper**

**Spherical Bearing**

*Figure 3. Viscous Fluid Damper*

Installation of the dampers was relatively easy, requiring two men and a portable hoist, and taking less than one hour per damper. The dampers have a ball type fitting at each end as shown in Figure 3, which provides angular freedom about the three axes, keeping the damper from experiencing moment loading when the two buildings twist relative to each other. These fittings made it easy to slip the damper into the supporting yoke and insert the large mounting pins through the holes in the yoke and ball fitting. The mounting pins were secured from falling out of the clevis connection with washers and cotter pins.

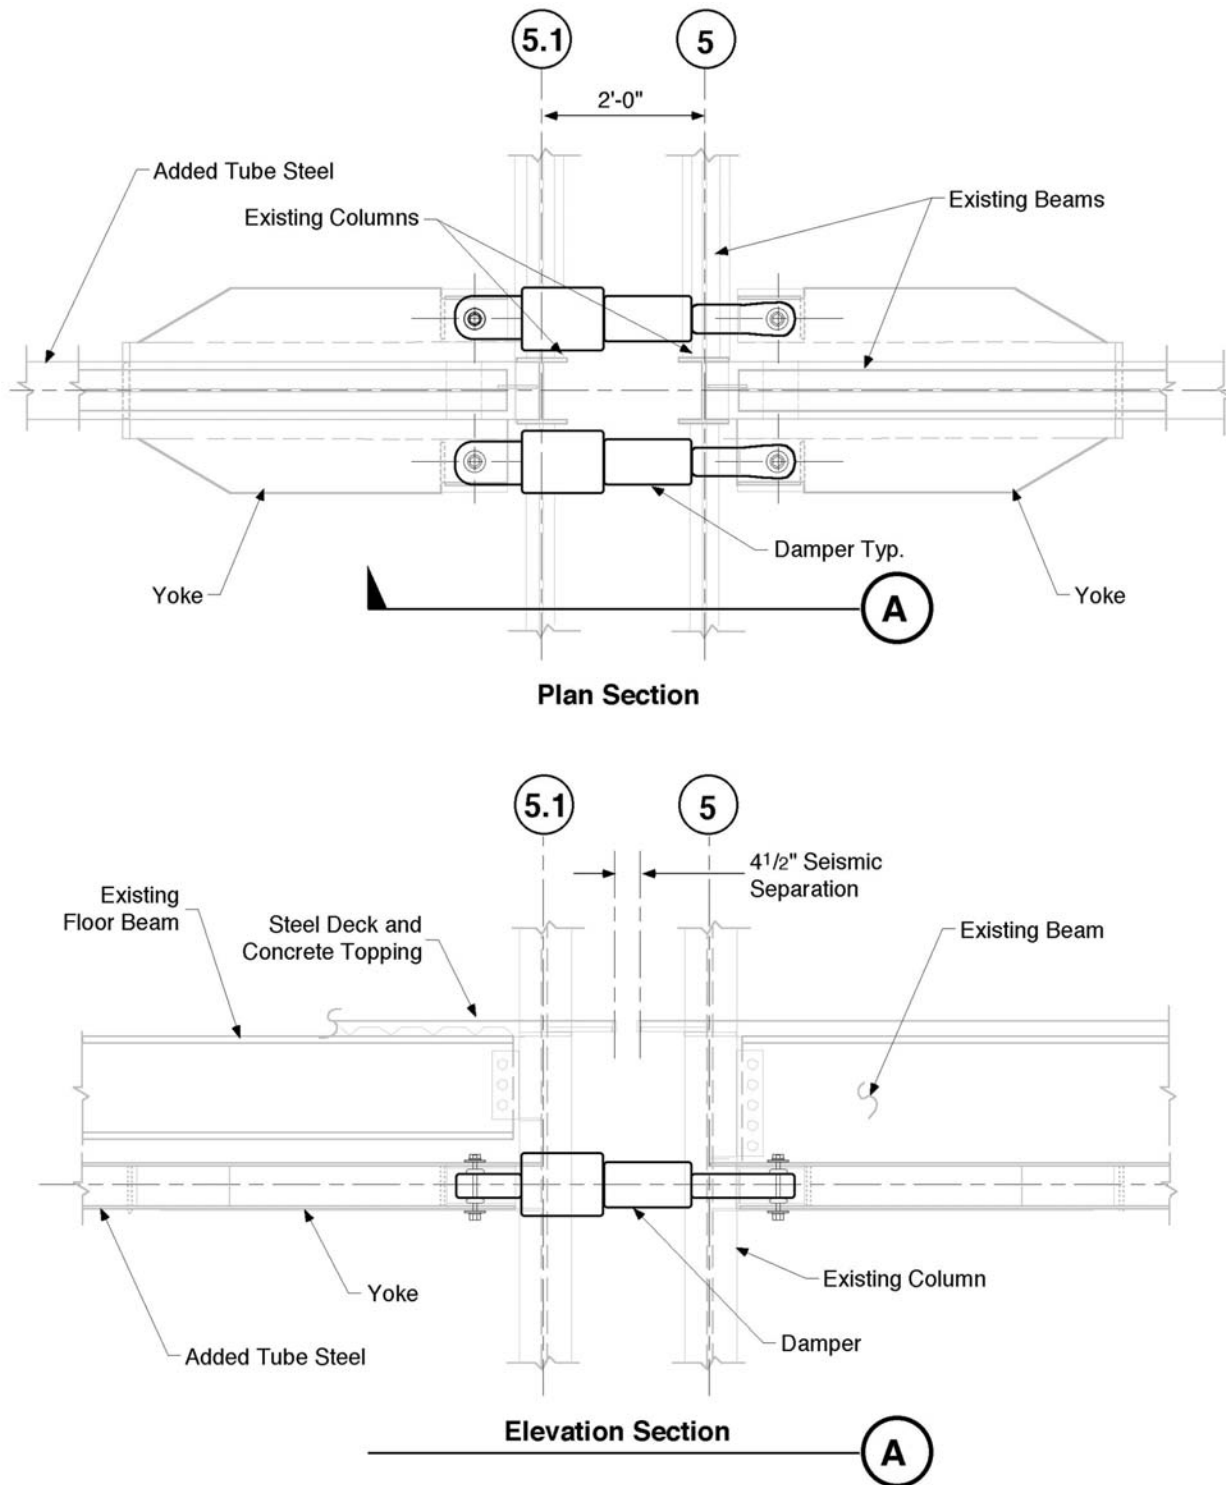
Figures 4 and 5 illustrate the typical damper and shear key installations along the seismic separation joint at lines 5 and 5.1. Two dampers were installed, one on either side of the main interior columns at the seismic joint as shown in the top of Figure 4. A single damper was installed at the exterior column at the re-entrant corner. The dampers were installed in a specially fabricated yoke of added tube steel, used to transfer the high concentrated axial forces in the dampers around the columns at the seismic joint and back into the structural framing system of the floor.

Figure 4. Typical Damper Installation

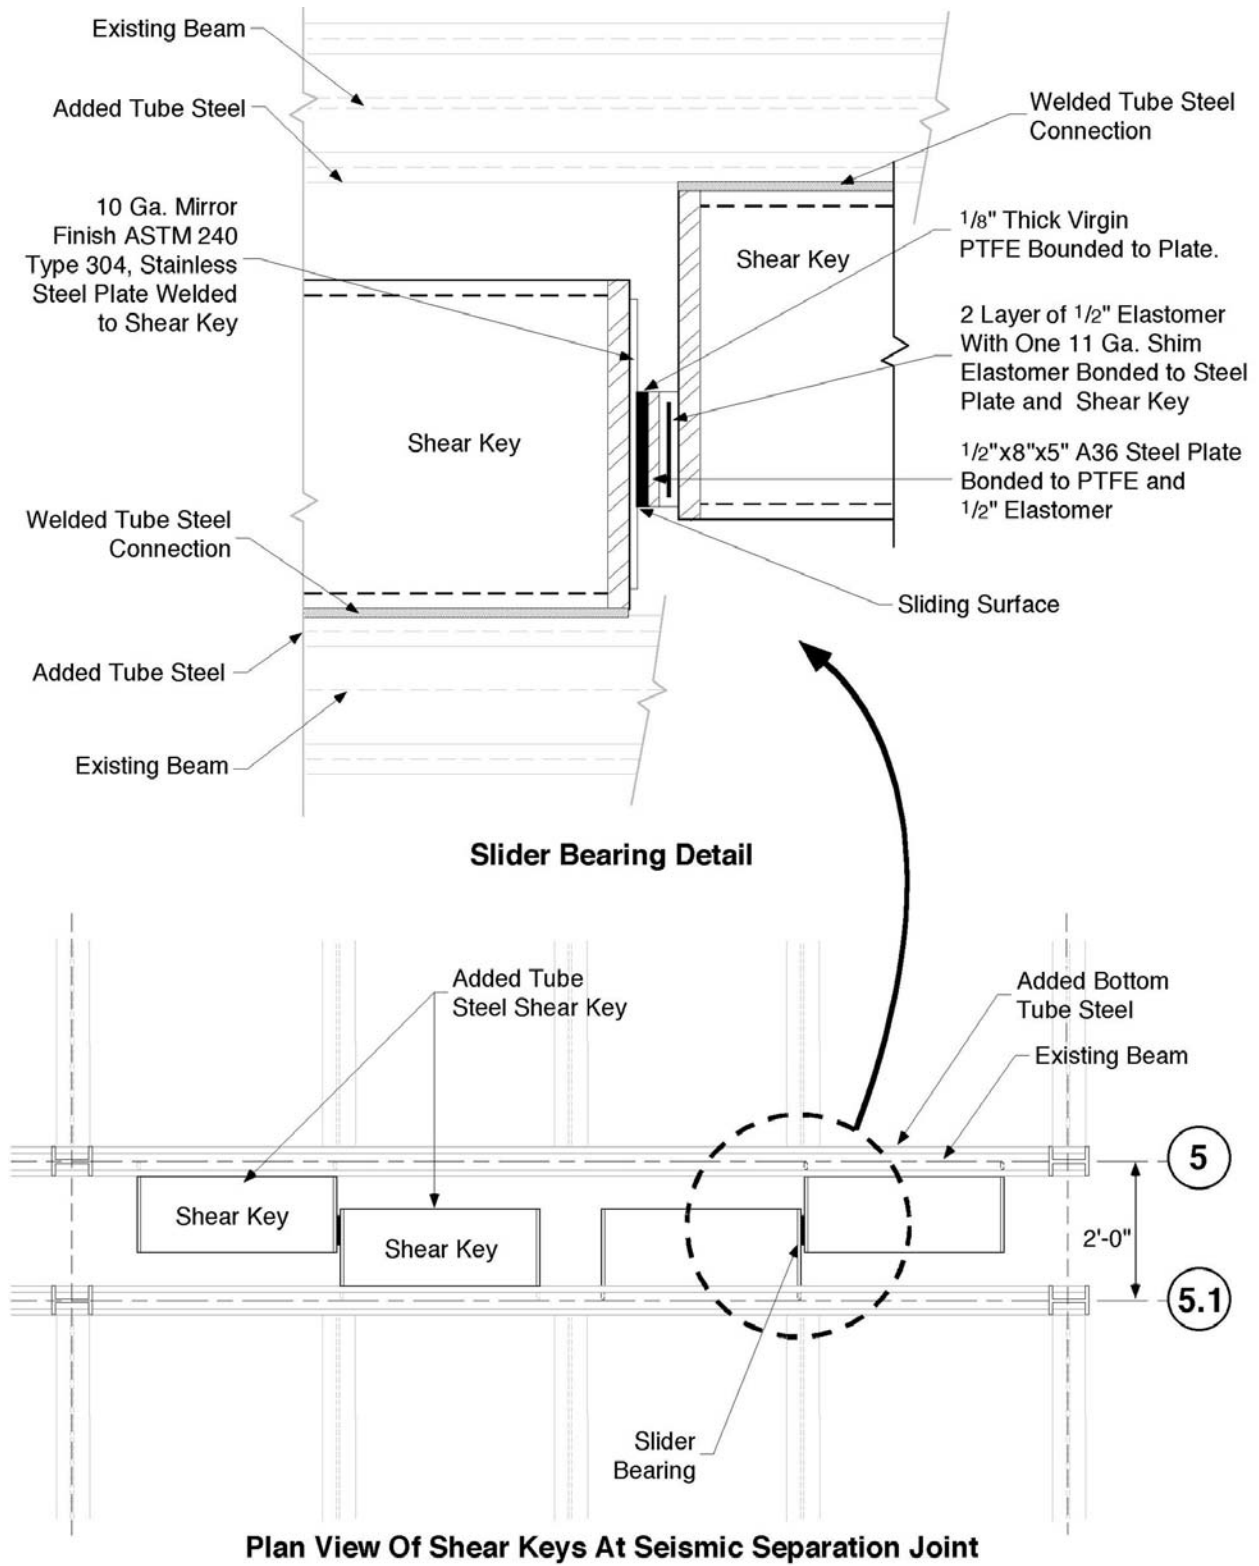
The axial loads from the yokes were transferred back into the floor framing through added tube steel welded to the bottom flange on the floor framing. These drag members were laterally braced to the underside of the floor to add stability. The tube steel yoke was shop fabricated and field welded into place. The shear keys were shop fabricated tube steel with end plates and sliders. The low coefficient slider as shown in Figure 5 was bonded to the bearing surfaces of the two abutting shear keys. The shear keys were field installed to a continuous tube steel drag element welded to the bottom flange of the beams on either side of the seismic joint on gridlines 5 and 5.1, as shown in Figure 5.

Figure 5. Typical Shear Key Installation
